Stantec Consulting Ltd.  
400, 10220 -103 Avenue NW  
Edmonton AB T5J 0K4  
Tel: (780) 917-7000  
Fax: (780) 917-7086

February 11, 2022  
File: 1135510101

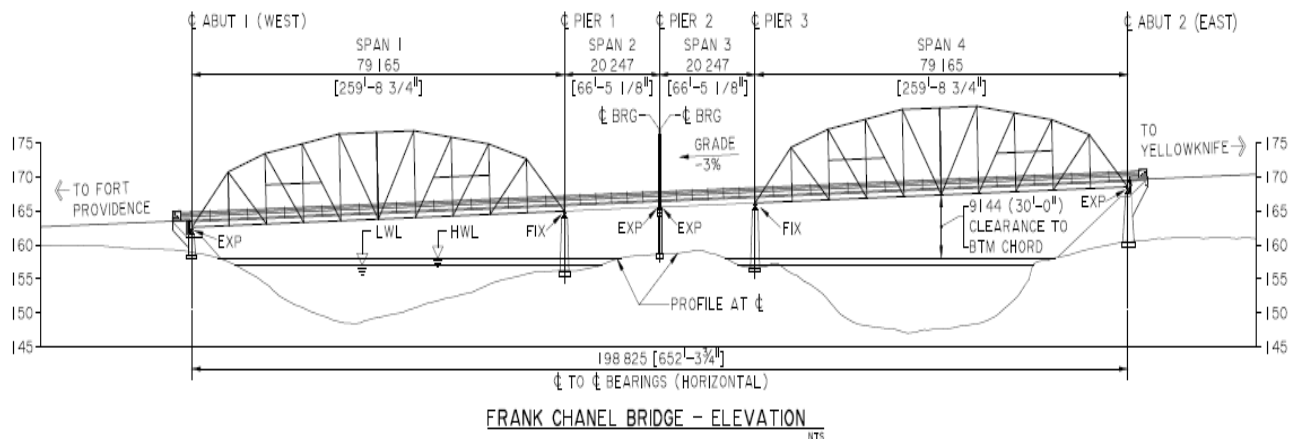
**Figure 2 Elevation view of Existing Bridge**

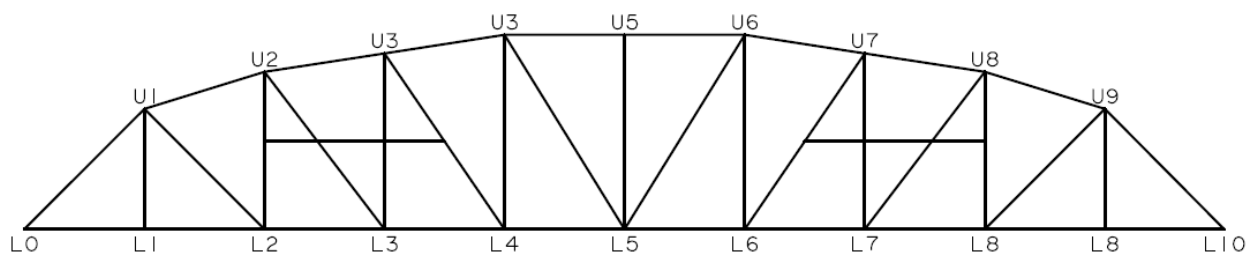
**Figure 5 Main Truss Member Labels (looking from South)**

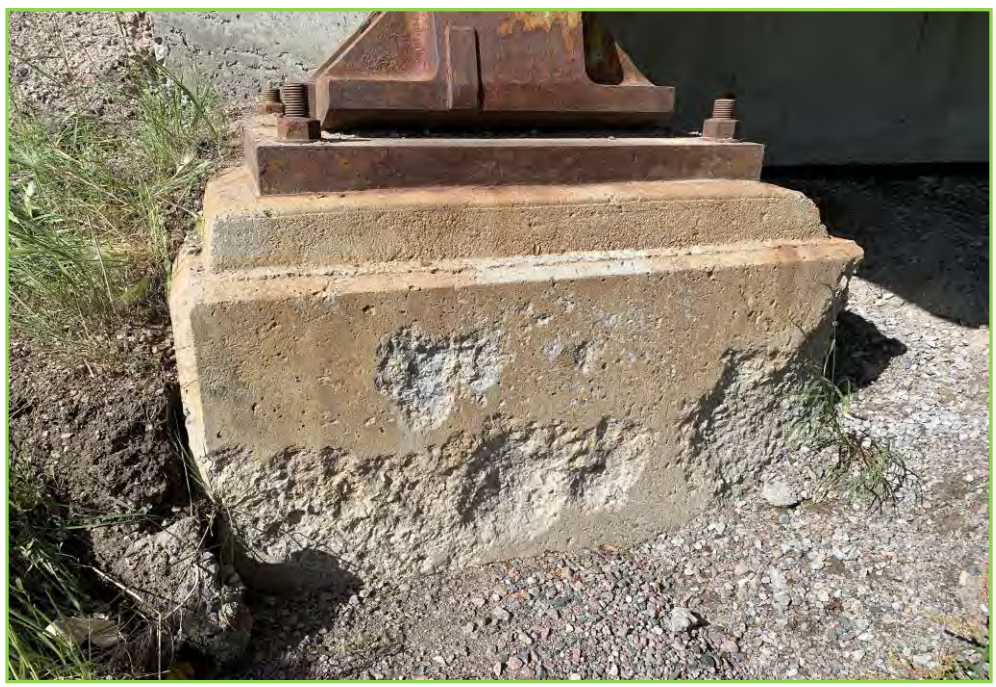
**Photo 4 –  
Abutment seat at  
Abut 1, Southwest,  
Minor Concrete  
Spall**

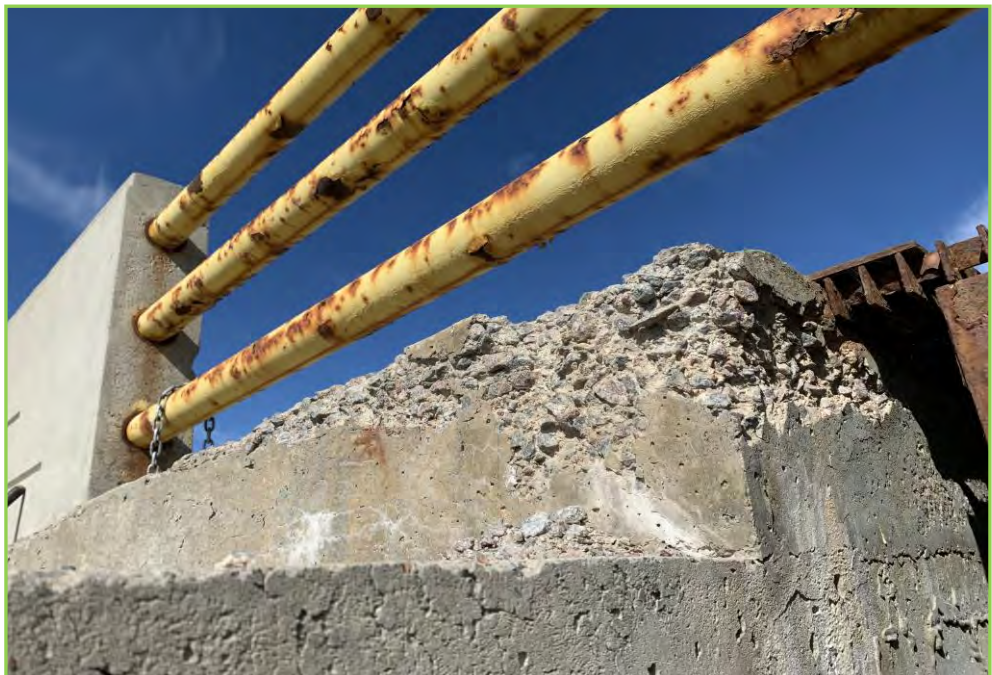
**Concrete Spall with Rebar Exposed at Abutment 1 Wingwall, Southwest**

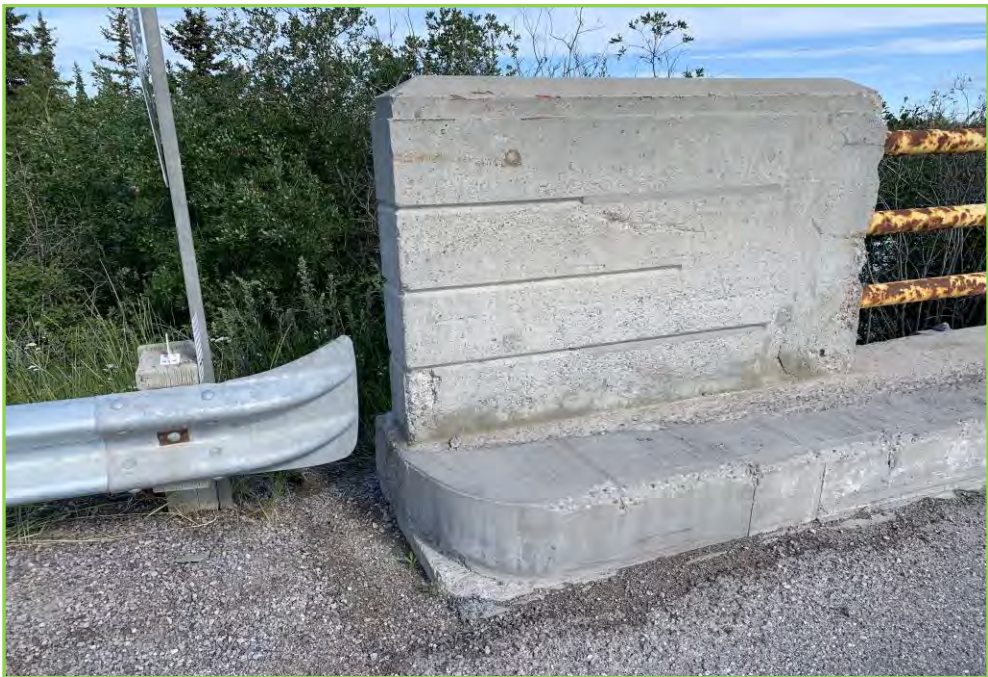
**Photo 9 –  
Concrete Parapet and  
Curb at Abut 1, Wide  
Cracks and Minor  
Spall noticed**

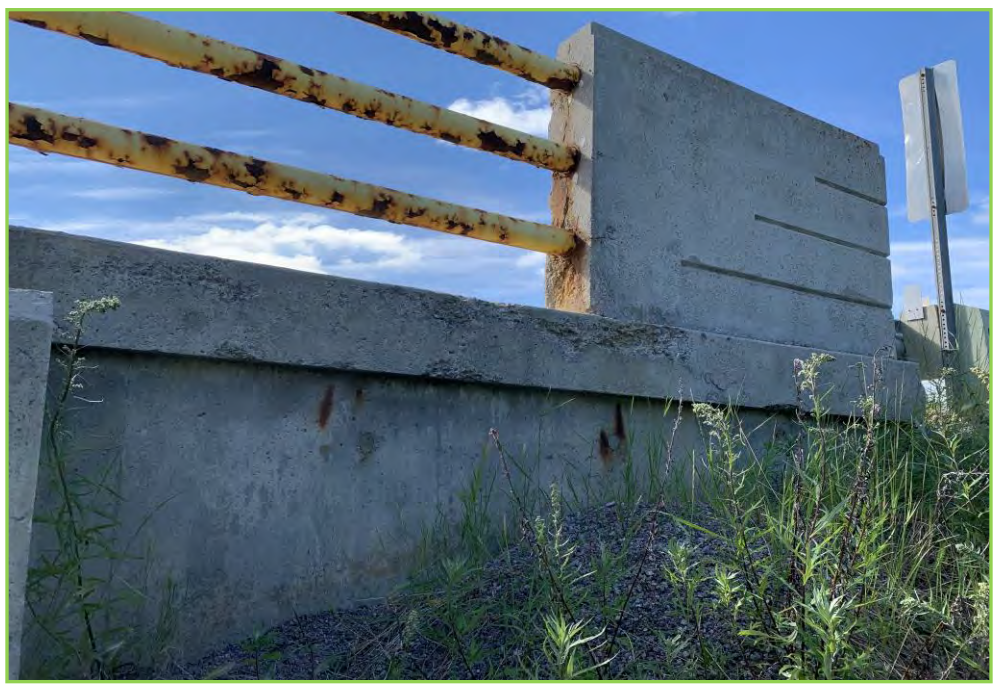
**Photo 10-  
Concrete Parapet  
and Wingwall at  
Abut 1, North,  
Severe Scaling and  
Minor Spall**

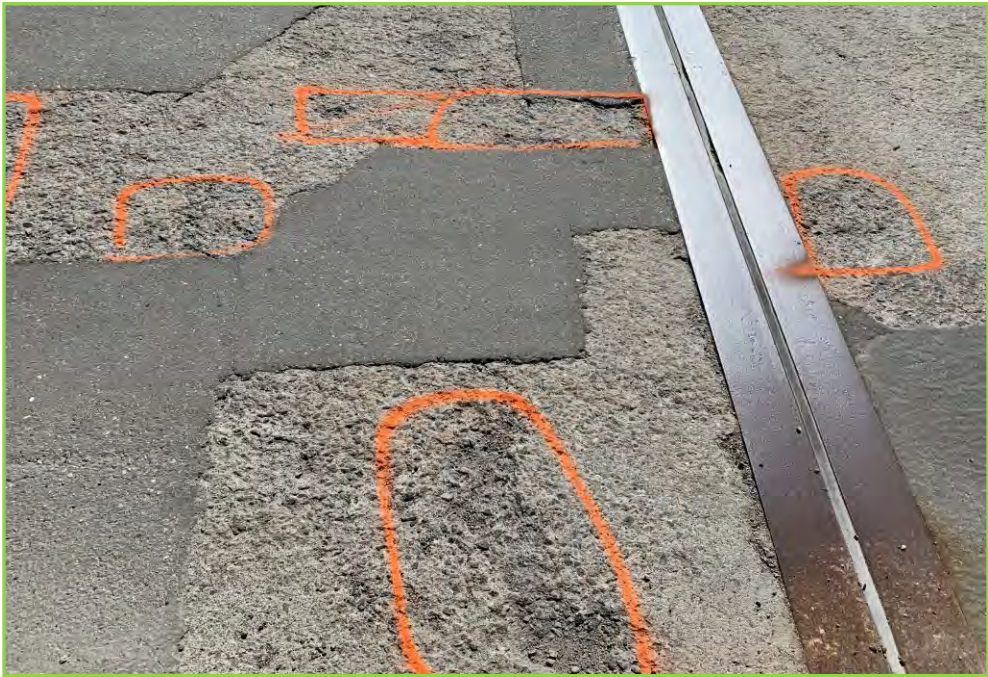
**Photo 13 –  
Concrete Spall,  
severe scaling and  
delamination near  
Pier 3**

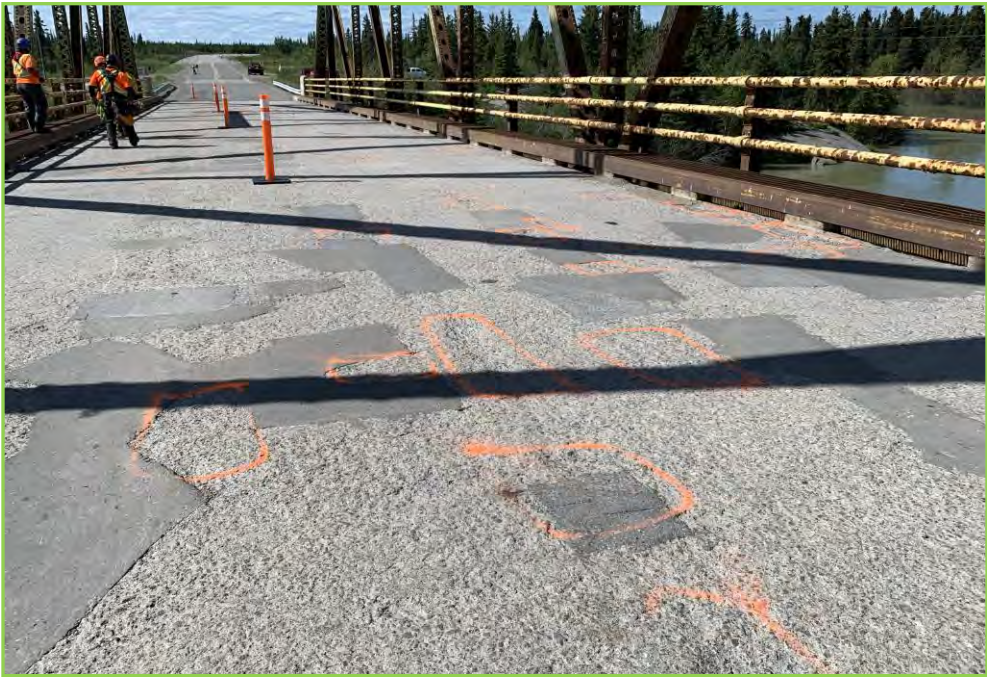
**Photo 14 –  
Delamination of  
Concrete Deck at  
Span 4 (Typical)**

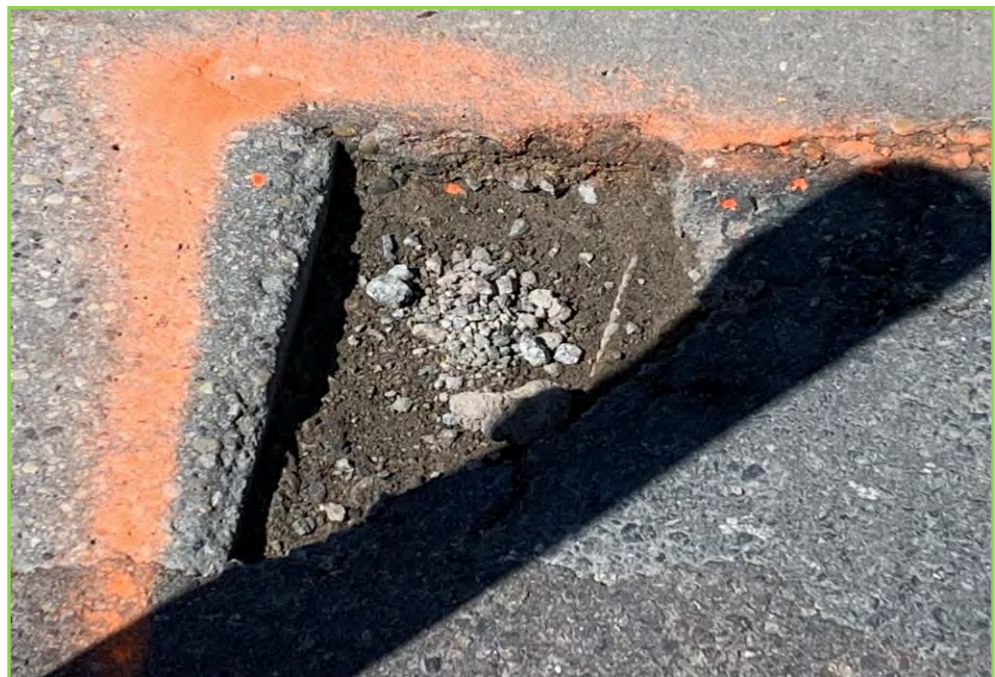
**Photo 16 –  
Concrete Spall  
(Pothole) at Span 1**

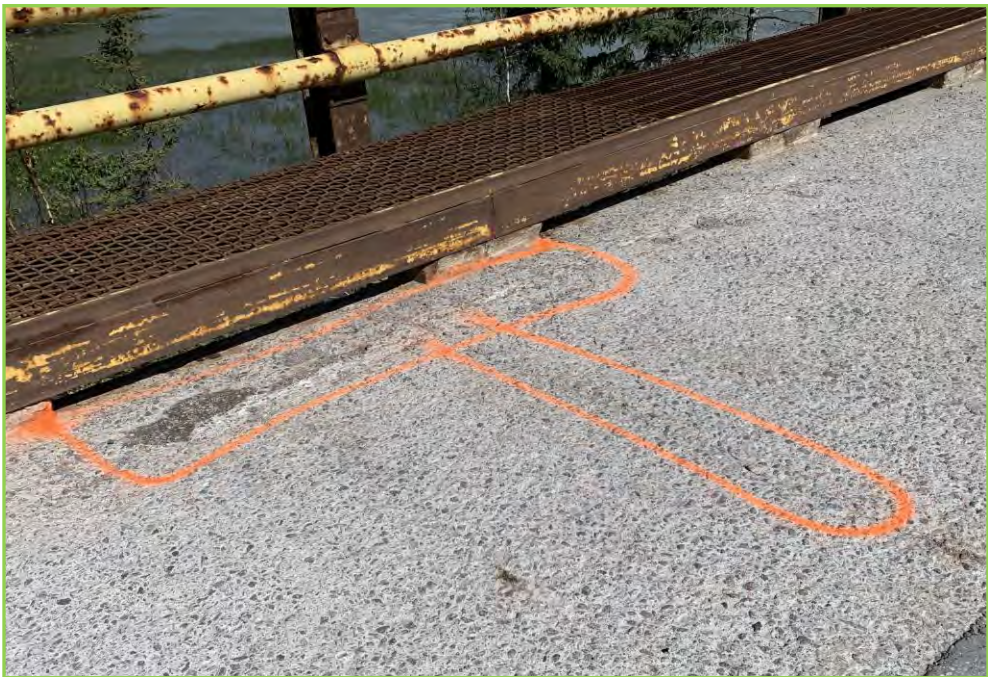
**Photo 17-**  
**Wide Crack and Concrete Spall at Span 1**

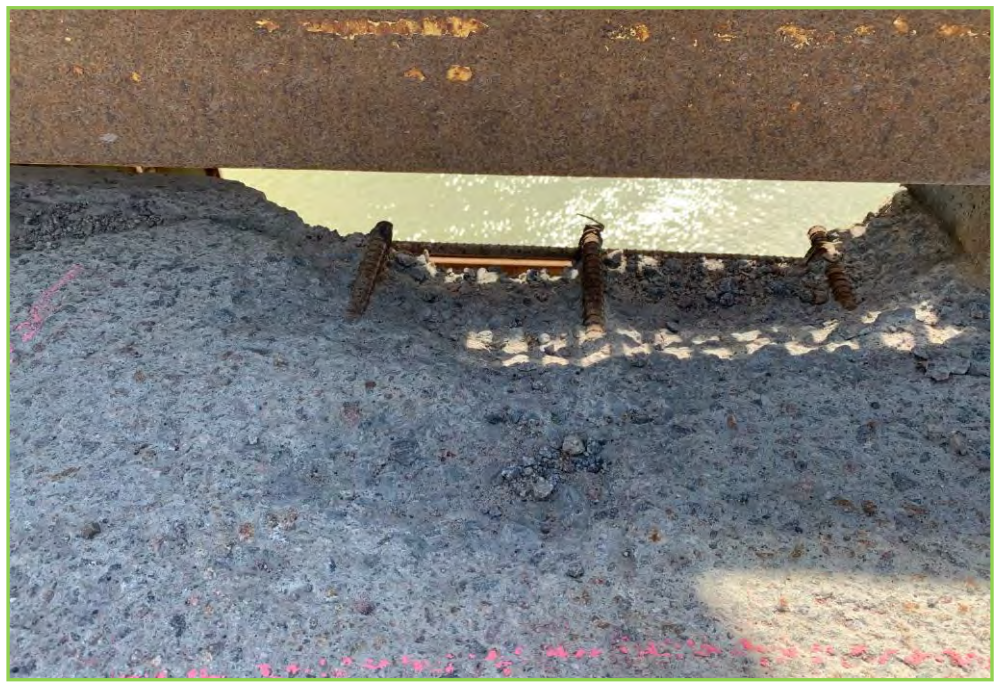
**Photo 18-**  
**Deck top Severe Spall with Rebar Exposed (Typical)**

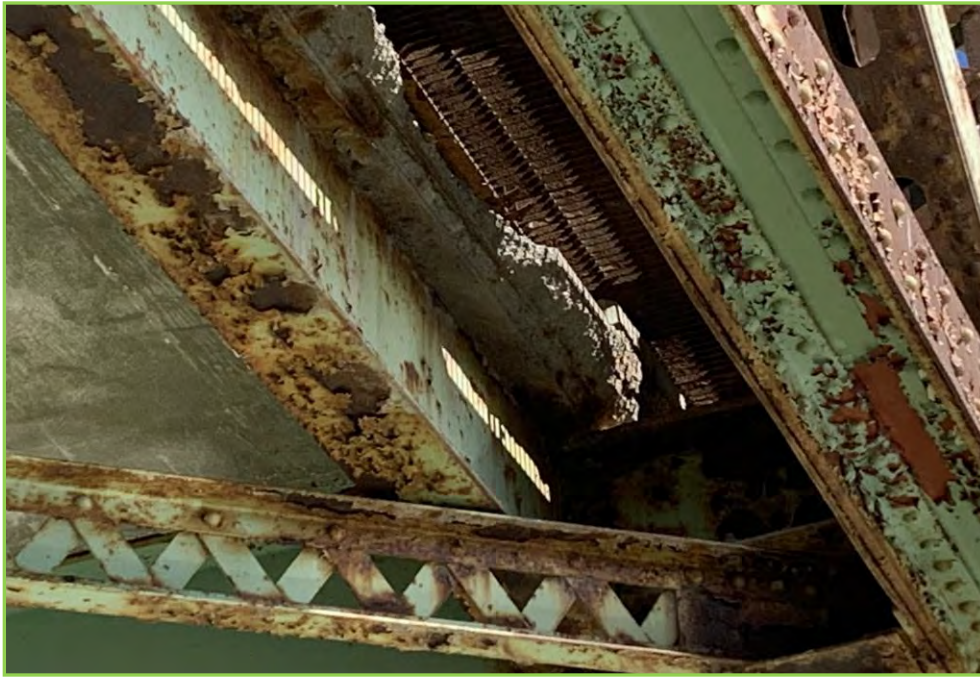
**Photo 19 –  
Deck Soffit- Exterior,  
Severe Spall with  
Rebar Exposed  
(Typical)**

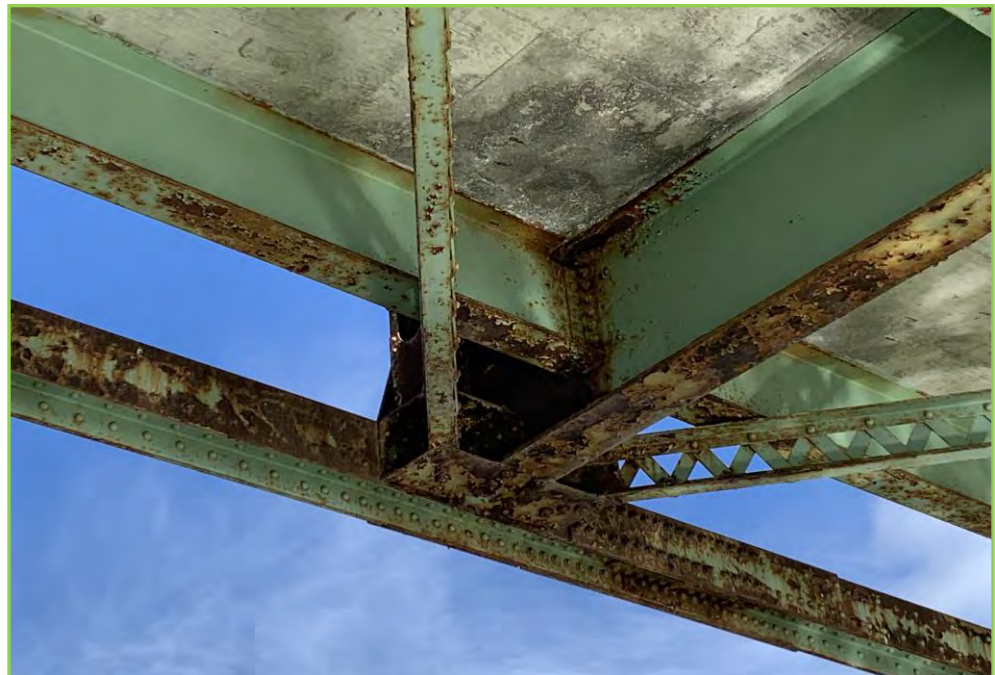
**Photo 020 –  
Deck Soffit at Span 1  
7<sup>th</sup> Intermedia Floor  
Beam, US,**

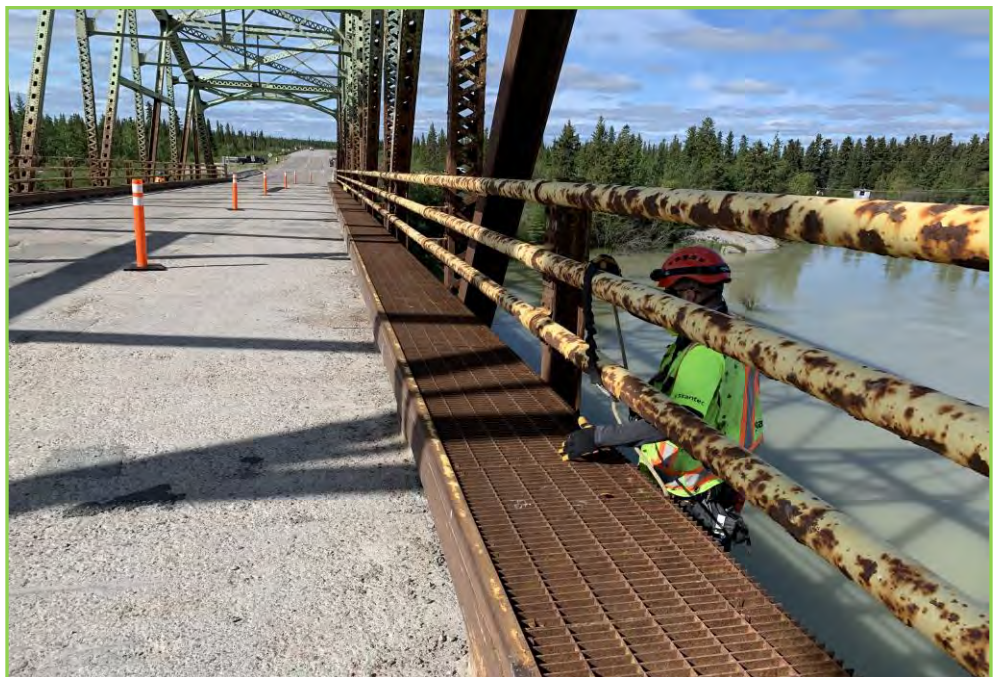
**Photo 030 –  
Steel Grating/Curb at  
Span 1, light Corrosion,  
Rusting with Coating  
Failed**

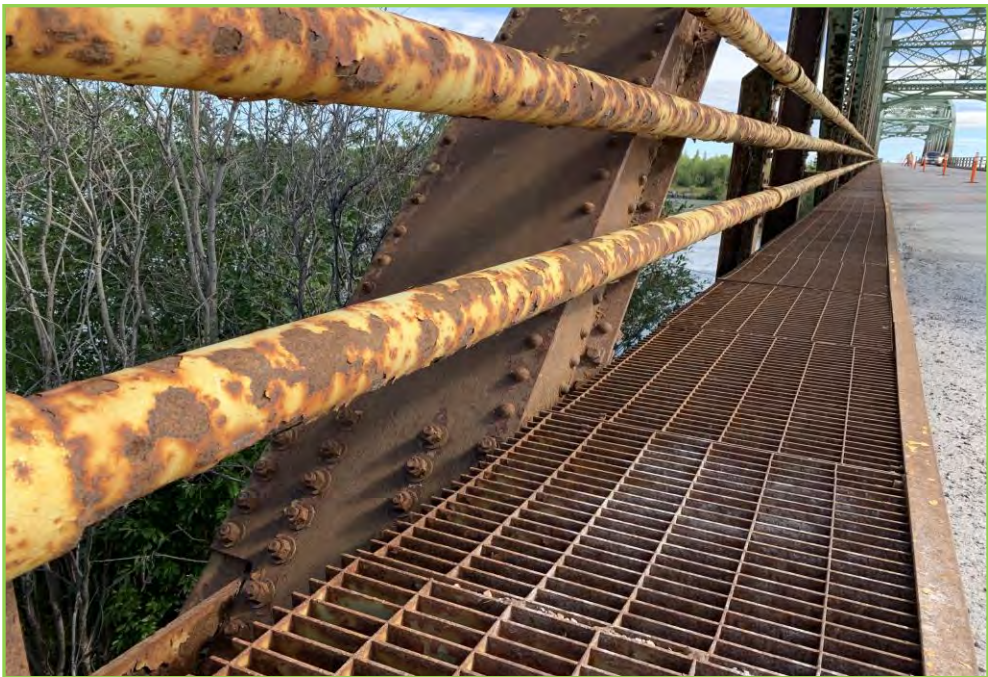
**Photo 031 –**  
**Steel Grating/Curb and Handrails at Span 1, light Corrosion, Rusting with Coating Failed**

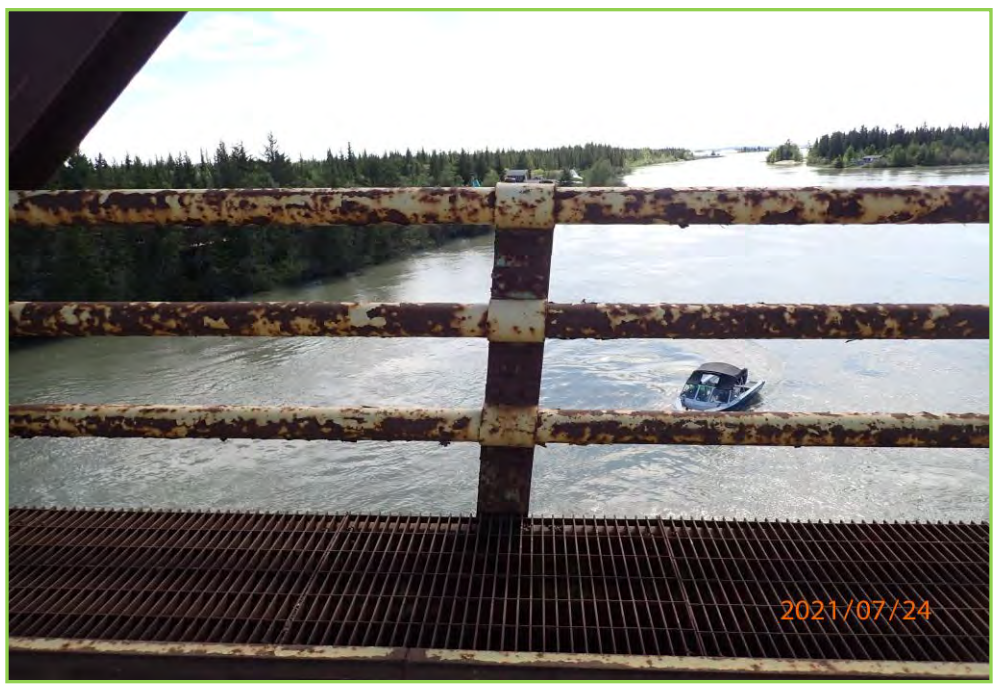
**Photo 032 –**  
**Handrail Post at Span 4, 4th form Abutment 1 at Southside (DS), Slightly Rotated to the West.**  
**Light Corrosion with Paint Peeled**

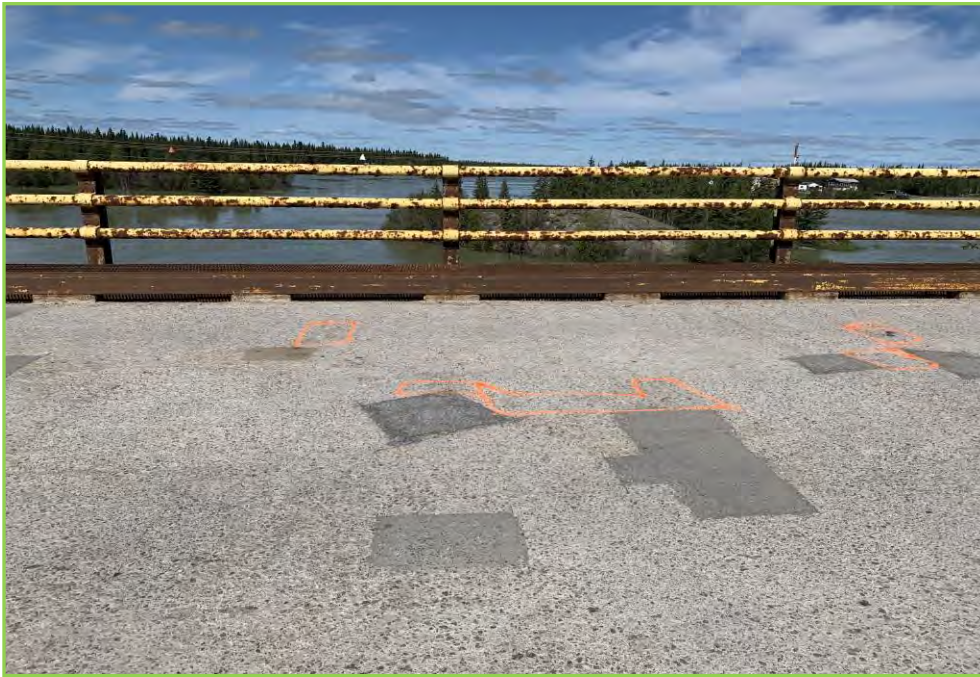
**Photo 033 –**  
**Handrails at Span 2,**  
**Typical paint peeled,**  
**Light Corrosion with**  
**No Section Loss**

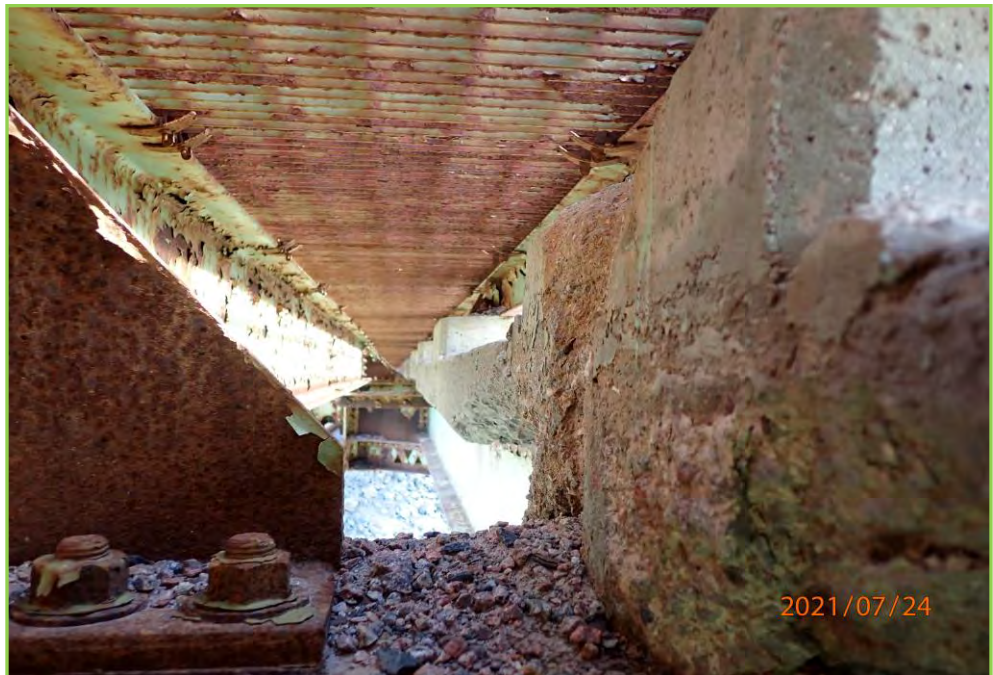
**Photo 034 –**  
**Underside of Concrete**  
**curb /Steel Grating,**  
**Light Corrosion.**

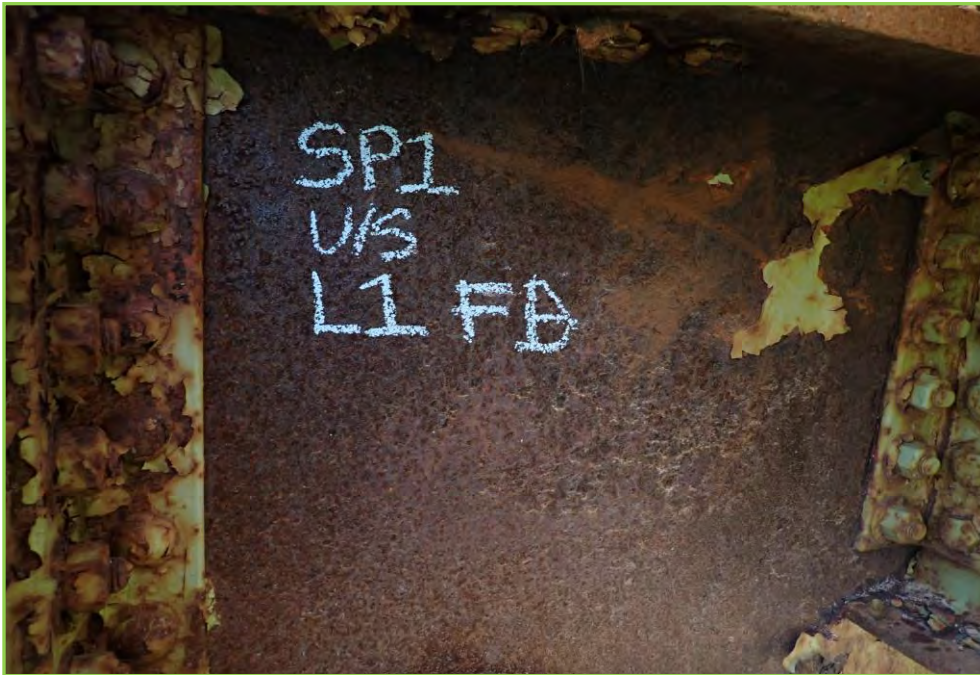
Project No 1135510101	
	Project: Highway 3 Frank Channel Bridge Inspection	
Location: Behchoko, NT	By: Ren Cheng, P. Eng.	
Date: July 24, 2021	Page: 18 / 49

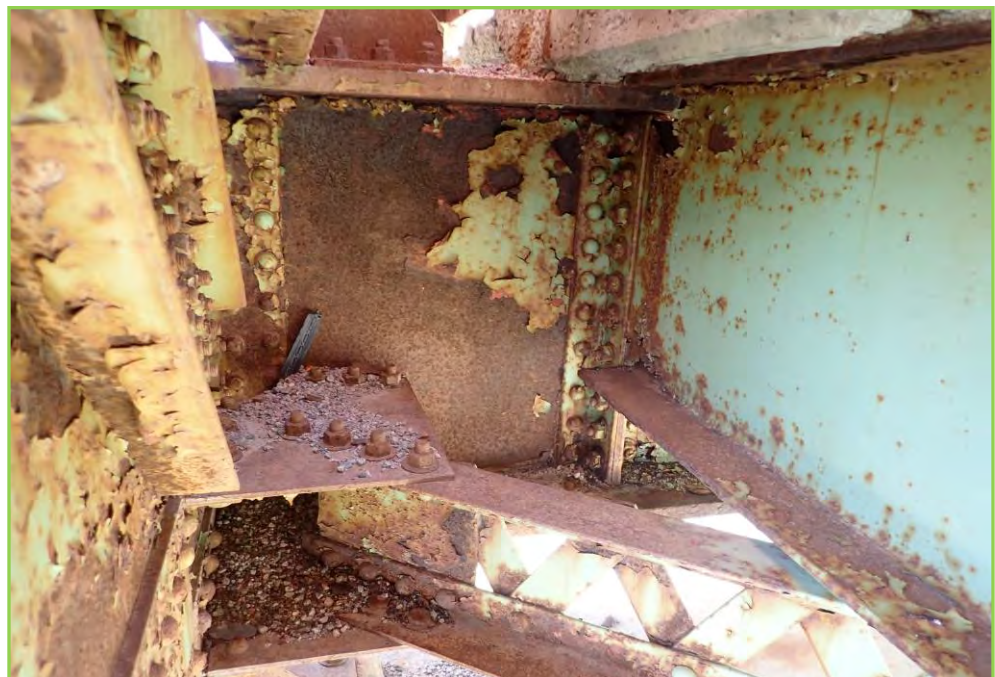
Floor Beam at Span1, L1, Typical, Light to Medium Corrosion on the Web at End with Section Loss 0-5%

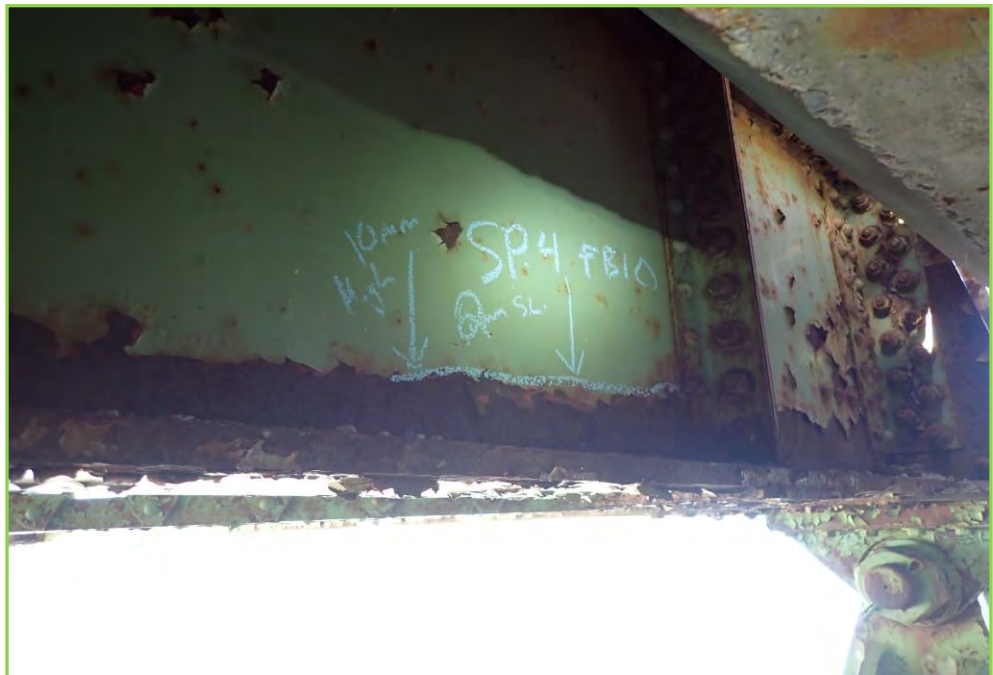
**Photo 038 – Floor Beam at Span4, L10, Pack Rusting Along Bottom of Web, Just Above Bottom Flange with 2 mm Section Loss.**

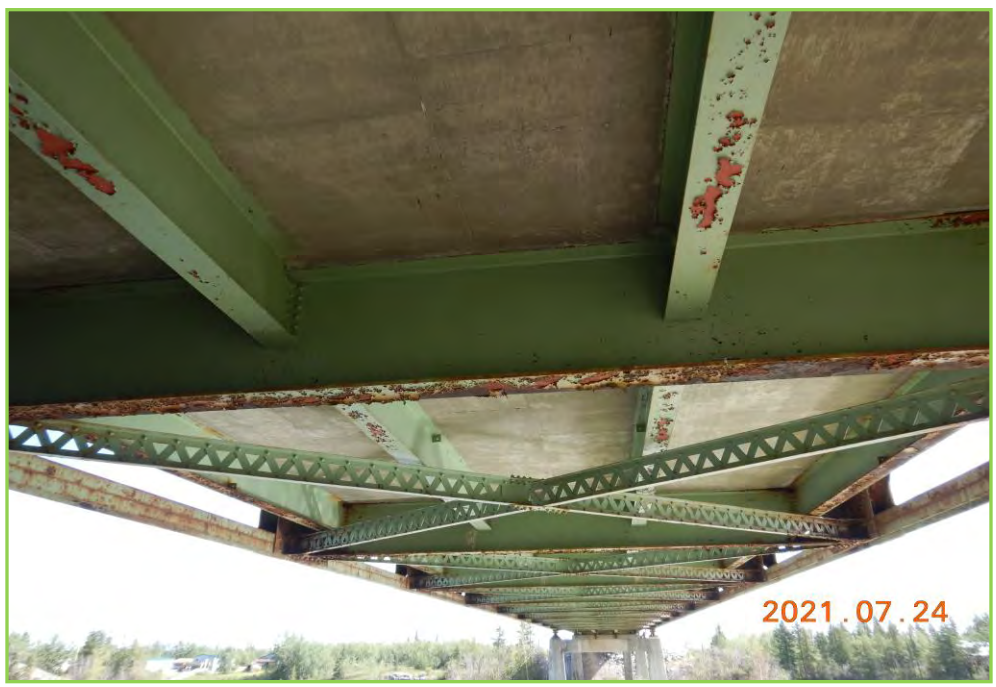
**Photo 040 –  
Stringers at Span 1,  
Typical in Good  
Condition**

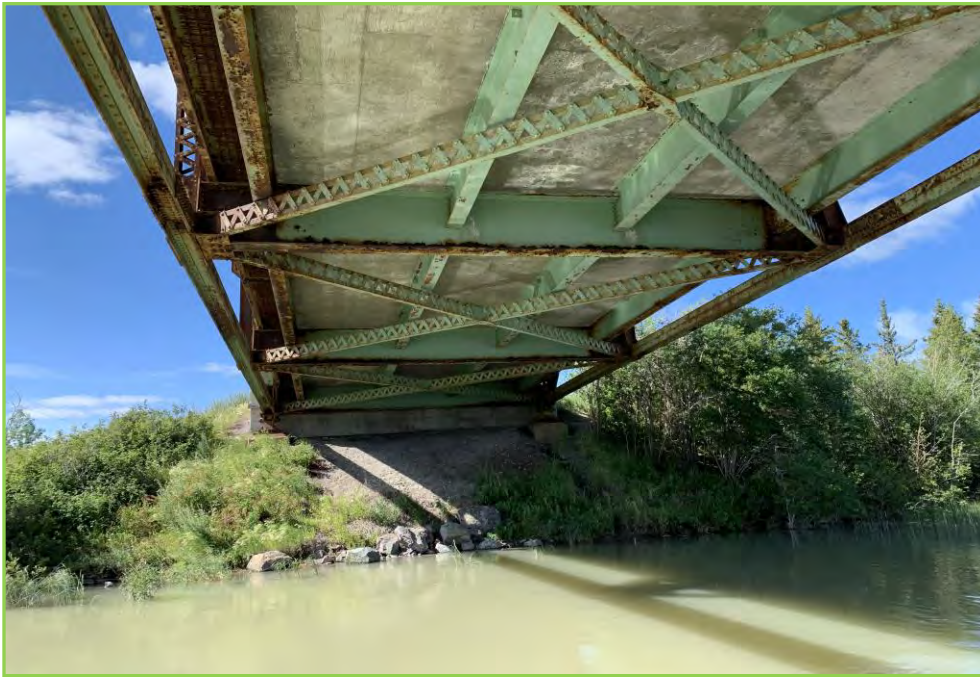
**Photo 041 –**  
**Underside of Span 1, Looking Abutment 1, Stringers and lateral Bracings, Typical Light Corrosion at the Bottom Flange of the Floor Beams and Exterior Stringers.**

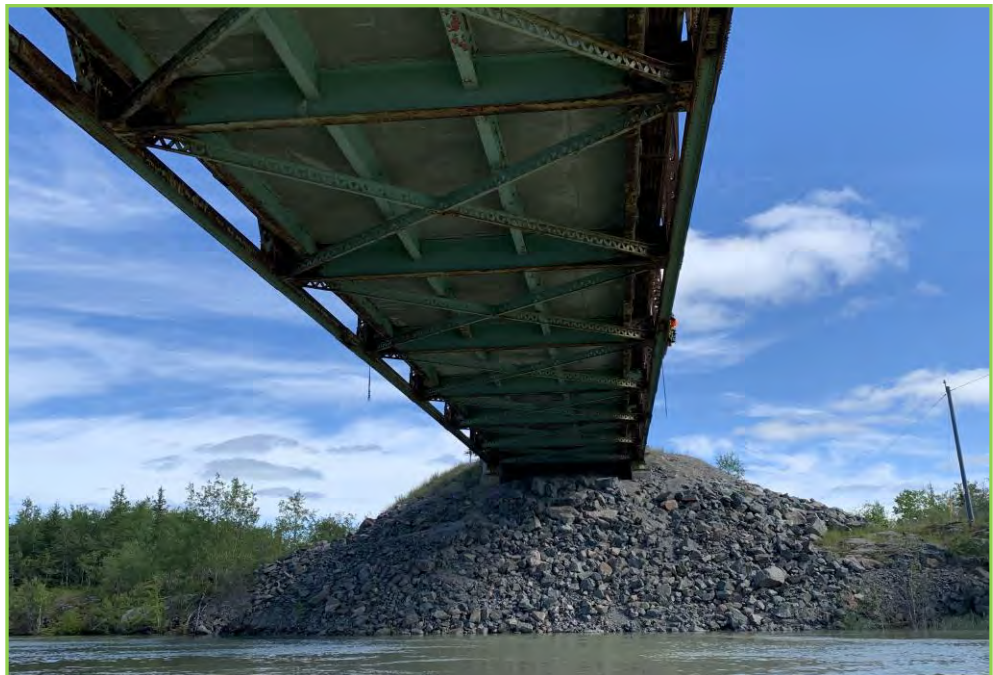
**Photo 042 –**  
**Underside of Span 4, Looking Abutment 2, Stringers and Lateral Bracings, Typical Light Corrosion at the Bottom Flange of the Floor Beams and Exterior Stringers.**

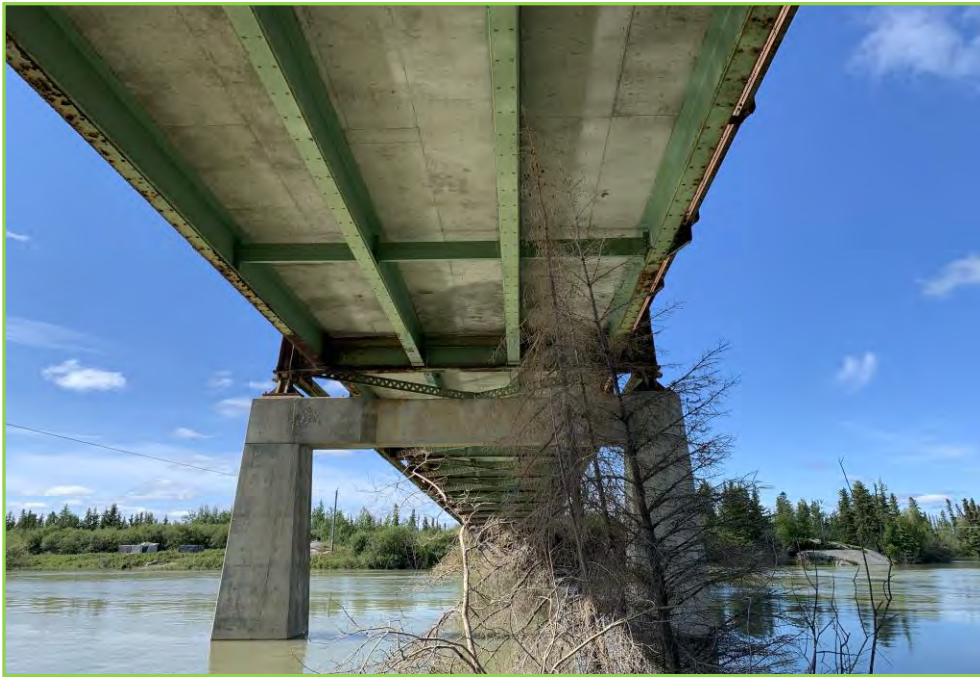
**Photo 043 –  
Underside of Span 2,  
Looking Pier 1,  
Girders, Typical Light  
Corrosion at the  
Bottom Flange of the  
Exterior Girders.**

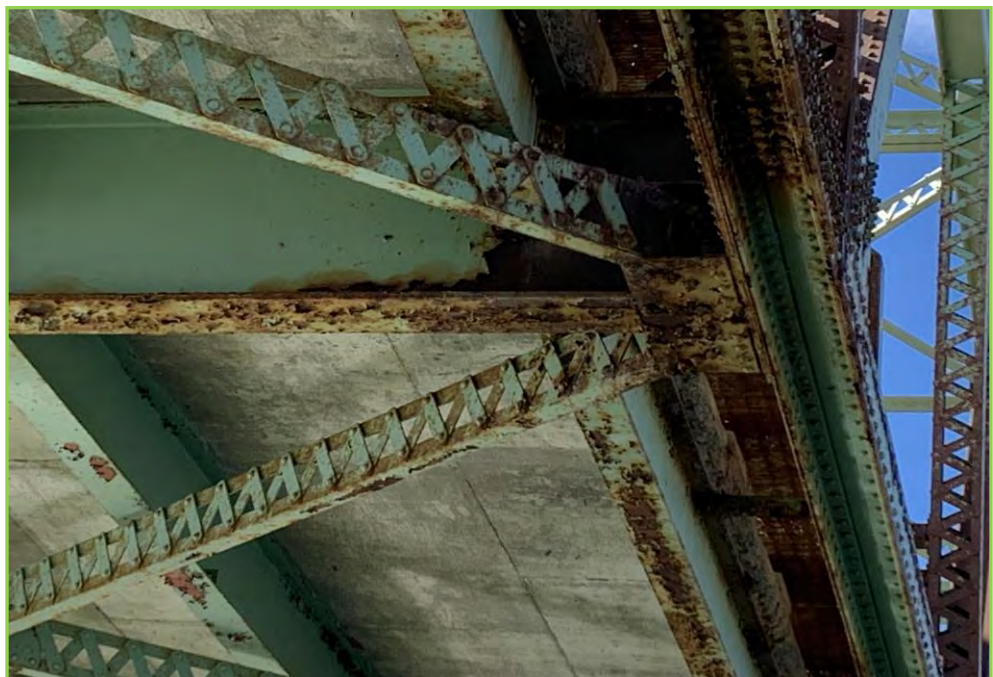
**Photo 044 –  
Connection of Floor  
Beam, Lateral Bracing  
and Bottom, Light  
Corrosion with Minor  
Section Loss**

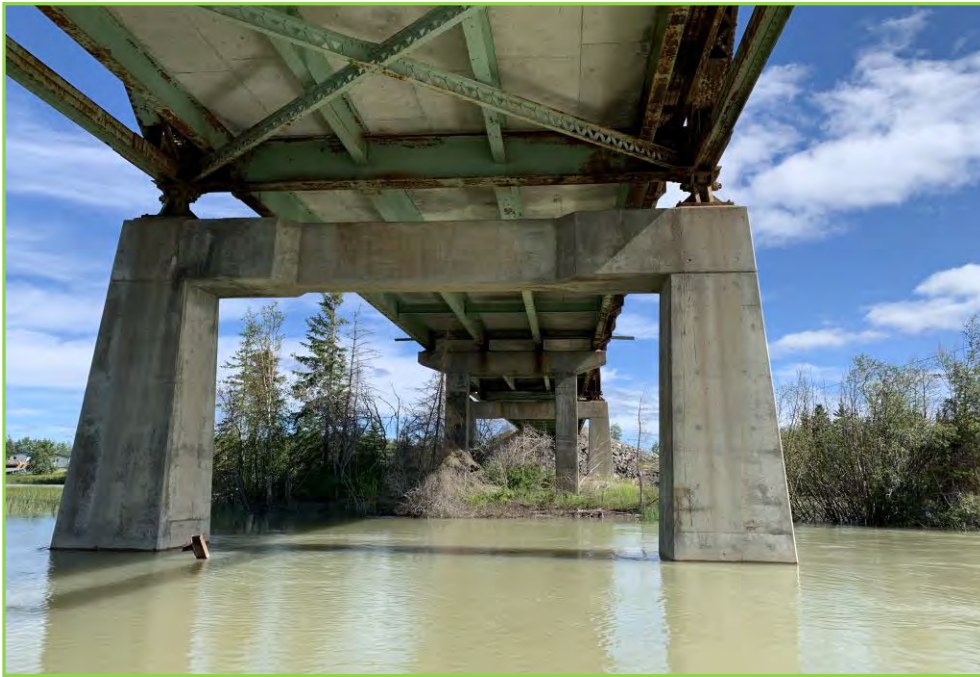
**Photo 045 –  
Pier 1 Looking East,  
In Fair Condition**

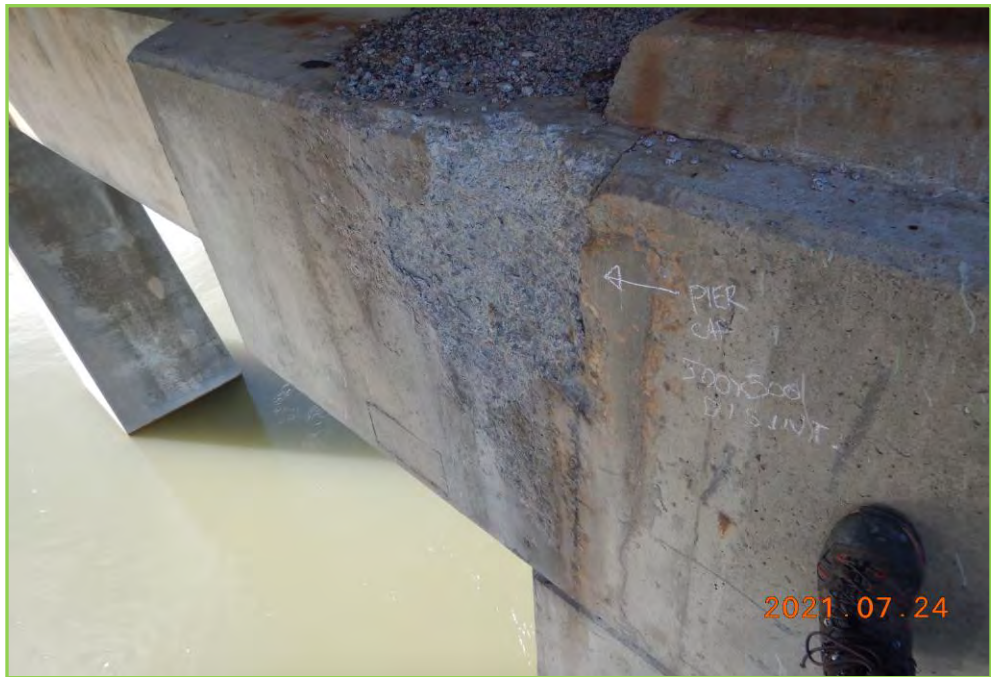
**Photo 046 –  
Concrete Spall at Pier 1  
Cap, 300mm x500mm.**

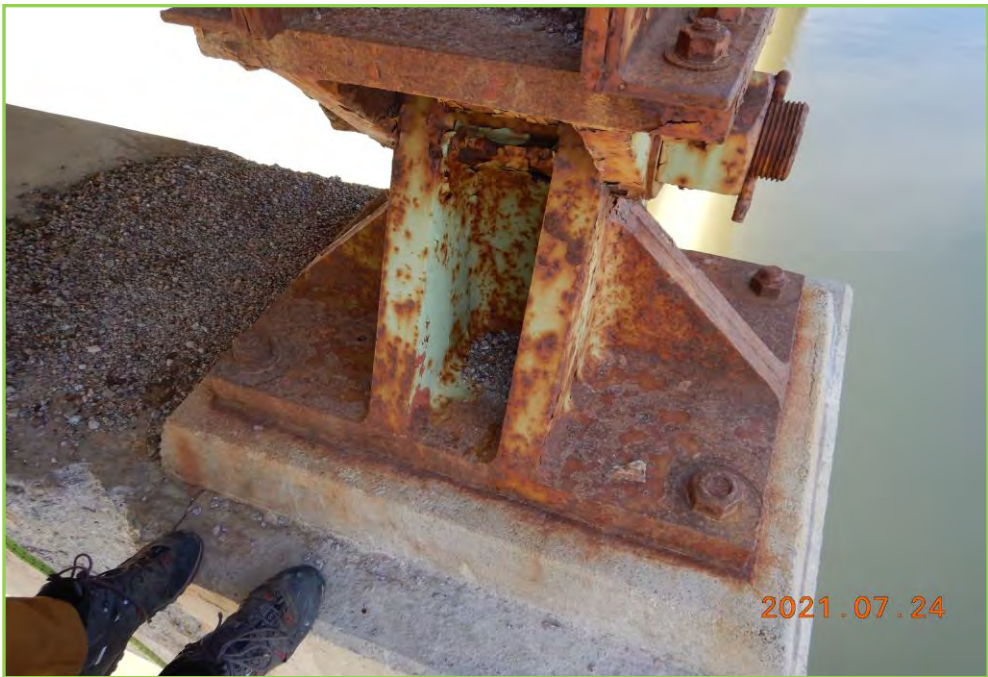
**Photo 047 –  
Bearing at Pier 1,  
Light Corrosion**

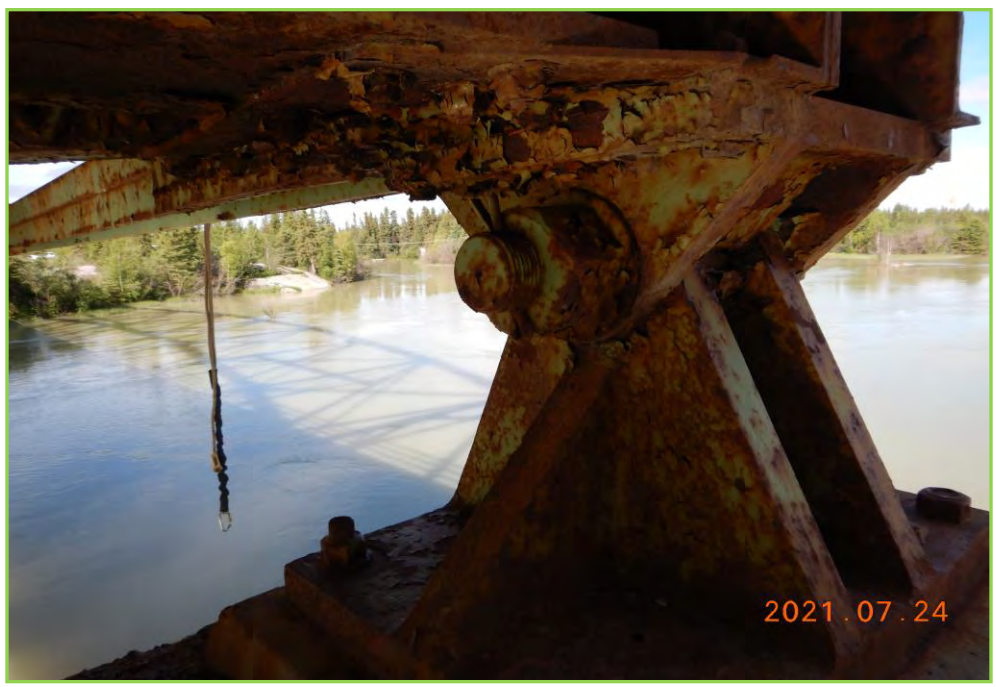
**Photo 048 –  
Rock Bearing at Pier 1**

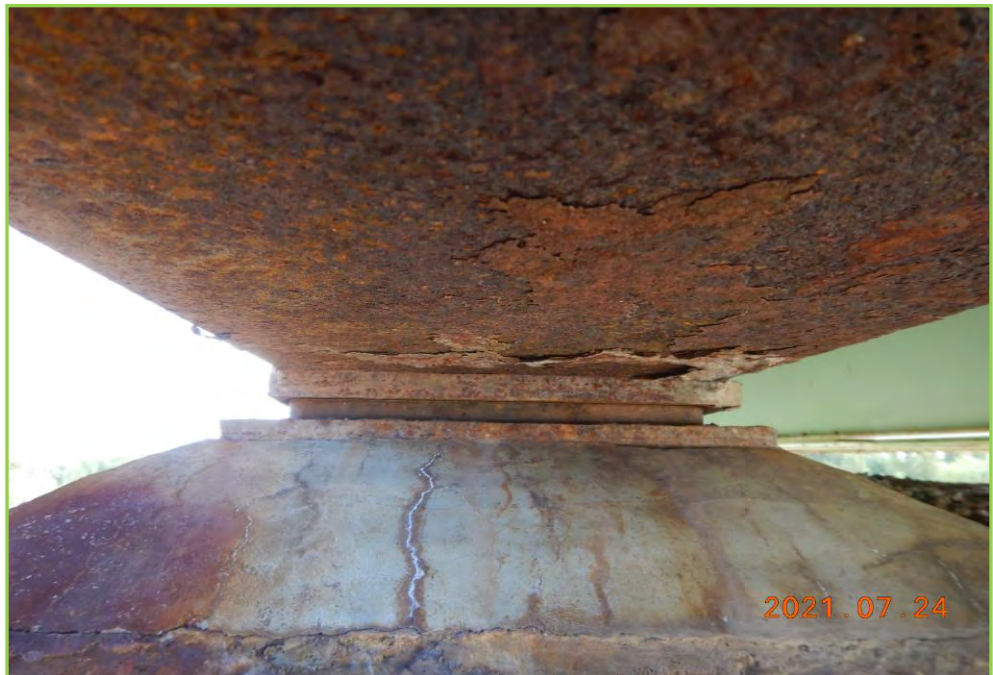
**Photo 052 –**  
**Girder 1 at US, Pier 2. Bottom Flange, Light Corrosion with Section Loss 0-5%.**

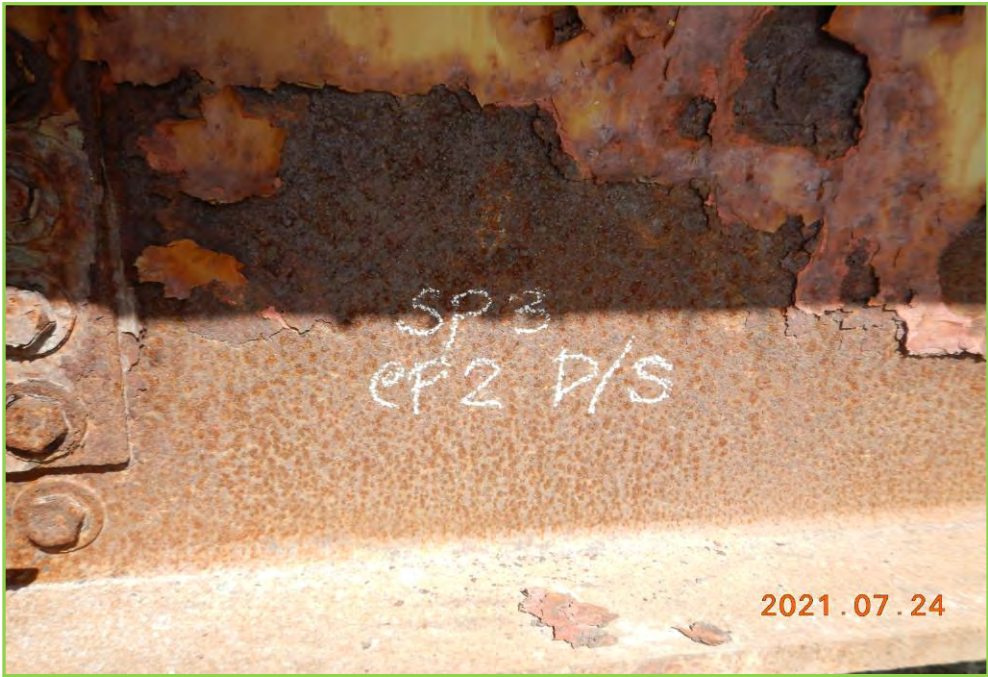
**Photo 053 –**  
**Girder 4 at DS, Pier 2,**  
**Web, Light Corrosion**  
**with Section Loss 0-**  
**5%.**

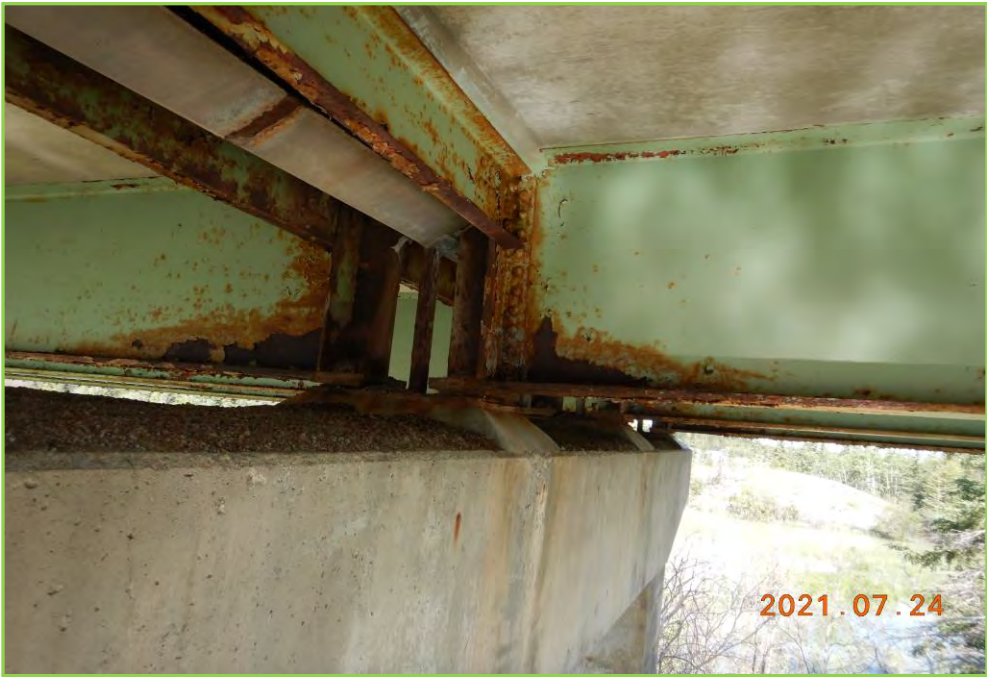
**Photo 054 –**  
**Top of Pier Cap, Pier 4.**  
**Light Corrosion at the**  
**End Diaphragm.**

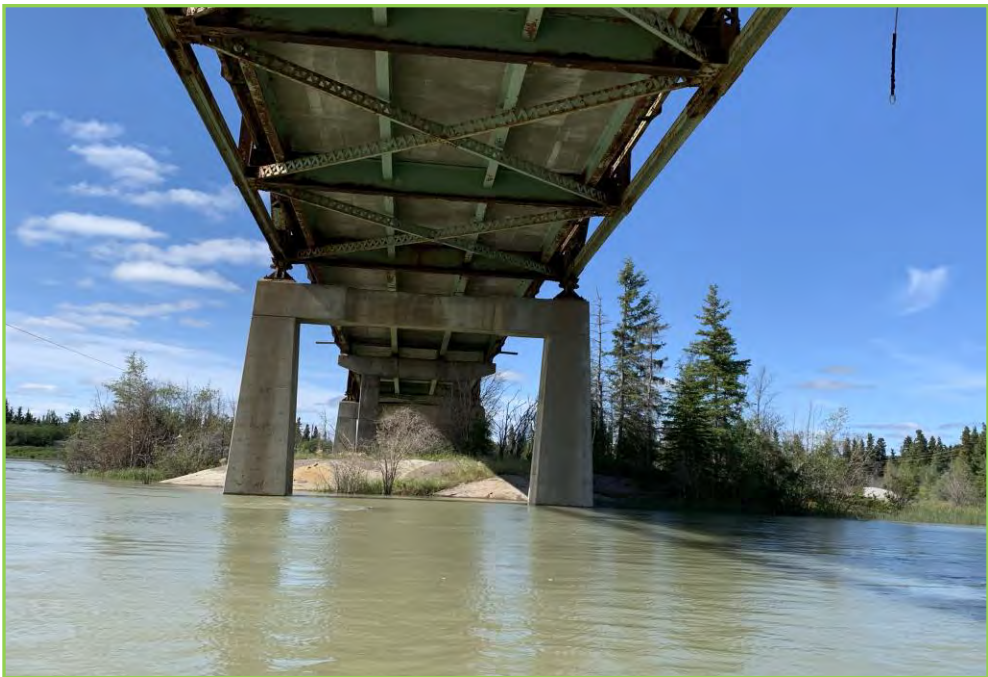
**Photo 057 –  
Pier 3 Looking West,  
In General Fair  
Condition**
