Stantec Consulting Ltd.  
400, 10220 -103 Avenue NW  
Edmonton AB T5J 0K4  
Tel: (780) 917-7000  
Fax: (780) 917-7086

February 11, 2022  
File: 1135510101

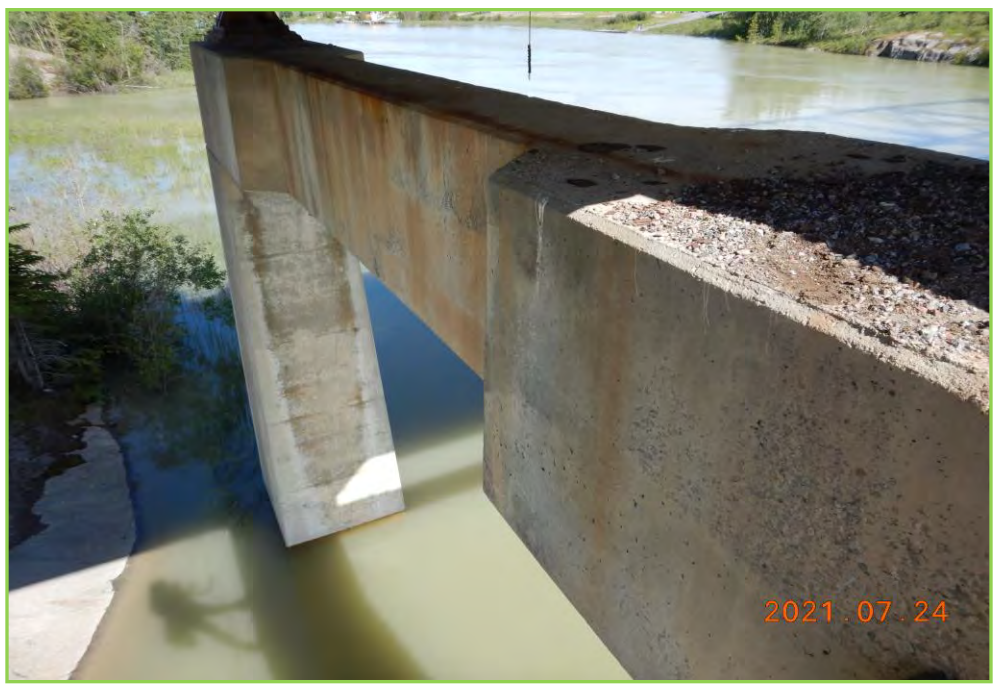
**Photo 058 –  
Pier Cap, Pier 3**

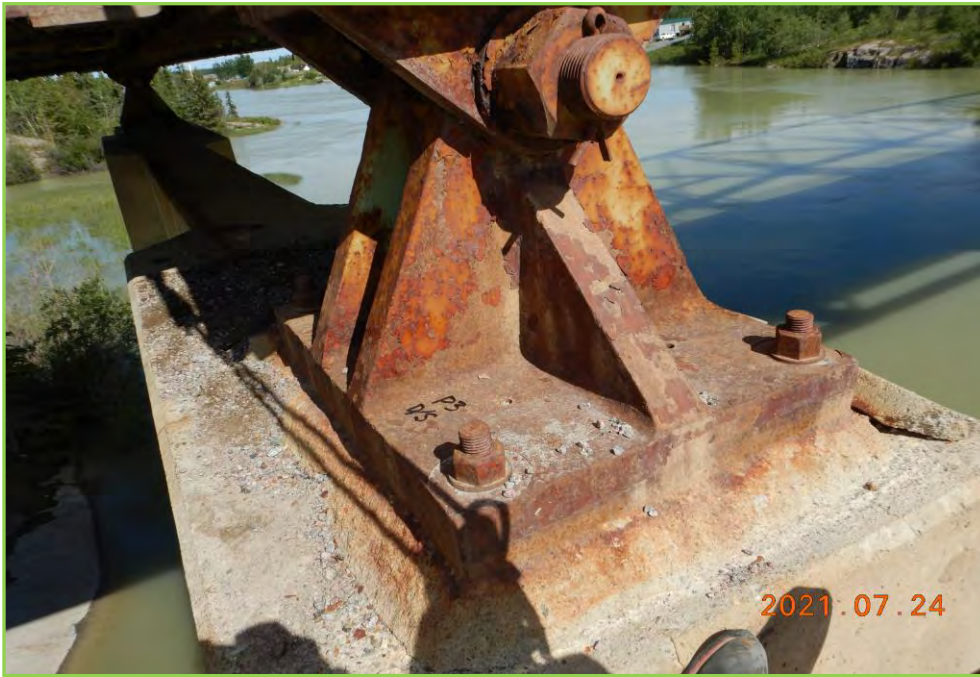
**Photo 059–  
Rock Bearing at Pier  
3, Light Corrosion**

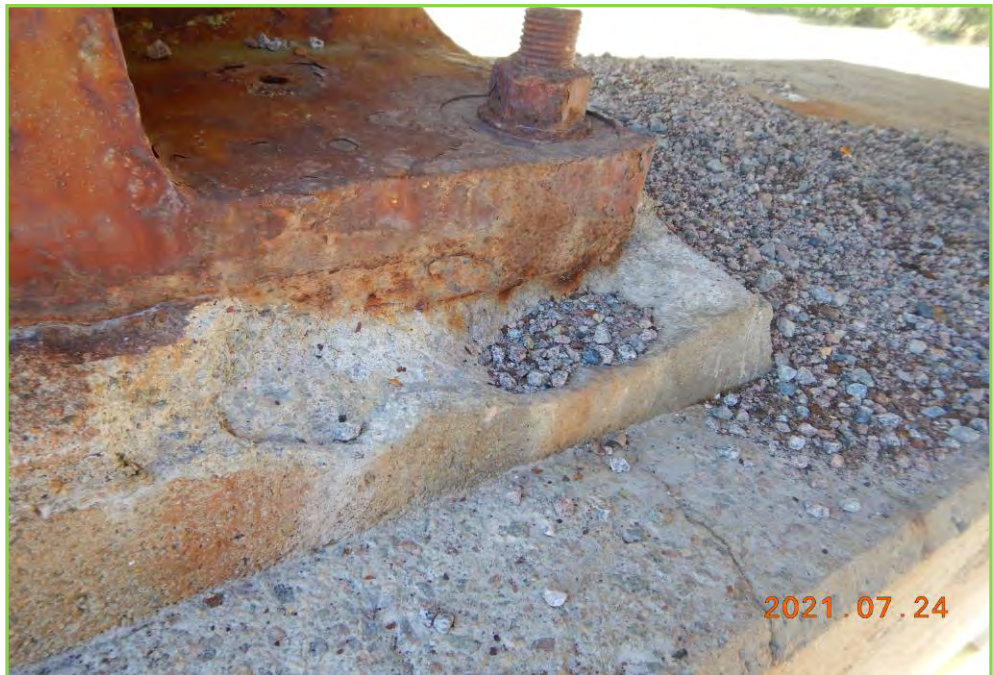
**Photo 060 –  
Concrete Scaling and  
minor Spall on the  
Bearing Seat, Pier 3**

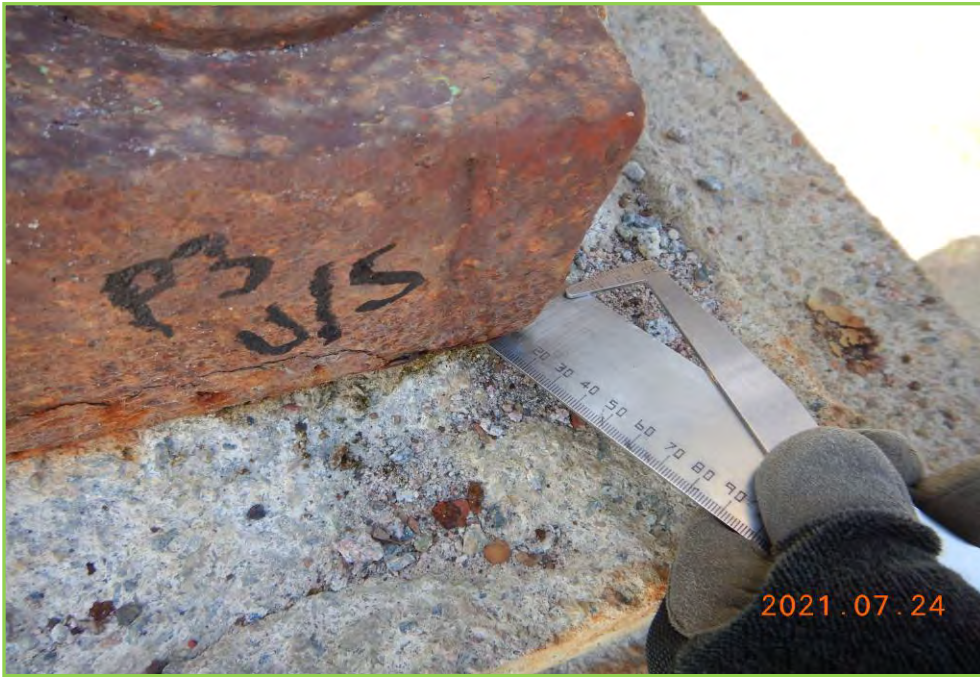
Photo 061 –  
Concrete/Grout spall  
at Bearing Seat, Pier  
3, US

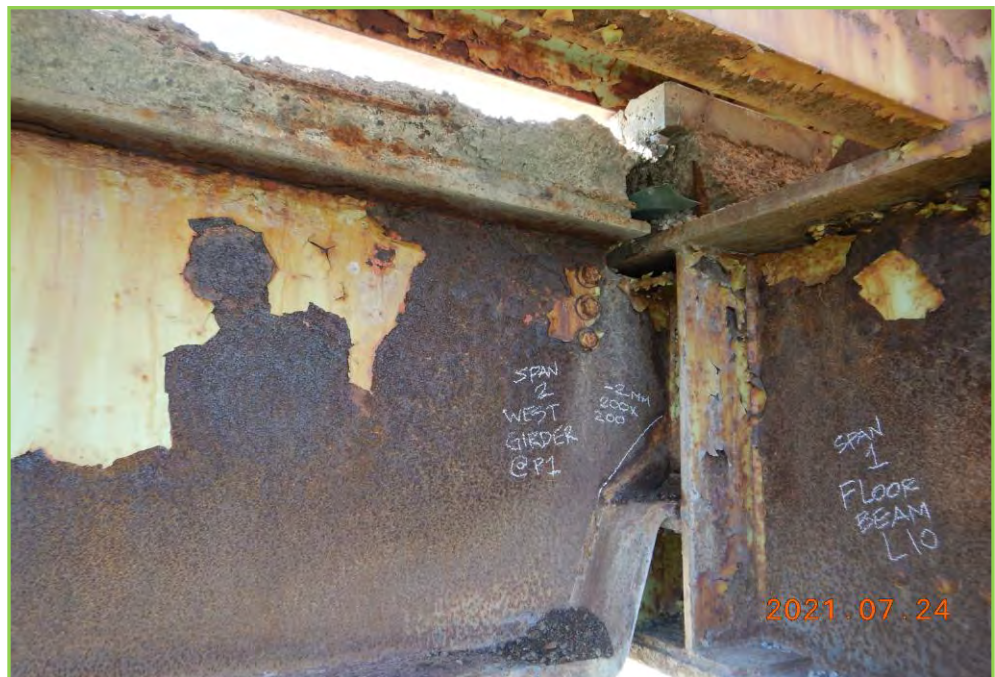
Photo 062 –  
Span2 , West Exterior  
Girder Support on  
Floor Beam L10 of  
Span1, Light  
Corrosion, Minor  
Section Loss,  
200x200mm, 2 mm

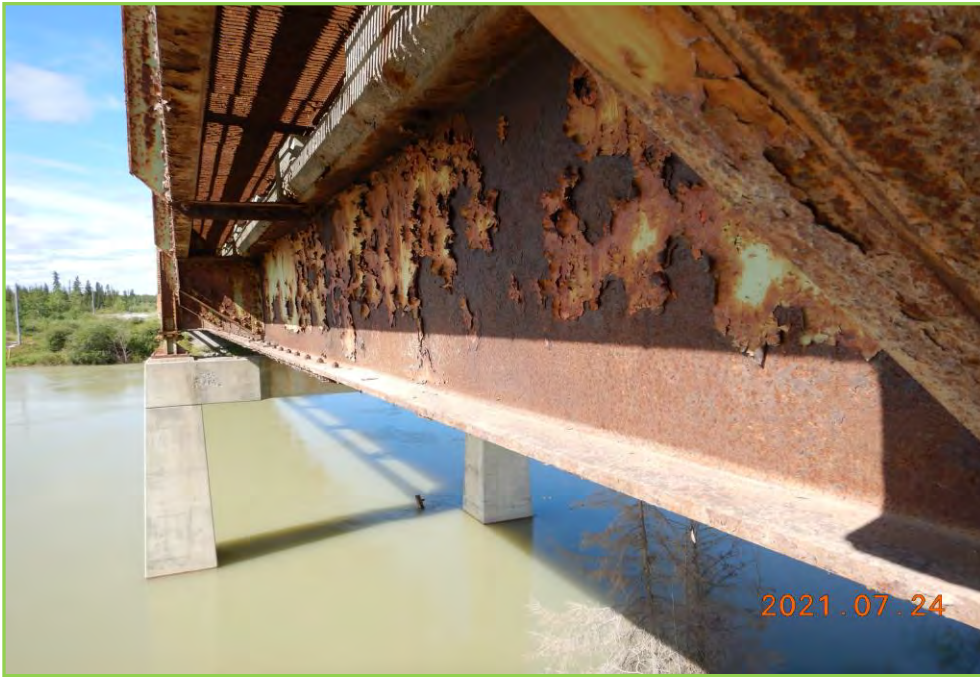
**Photo 063 –**  
**Typical Exterior**  
**Girder at Span 2,**  
**Light Corrosion with**  
**Minor Section Loss**

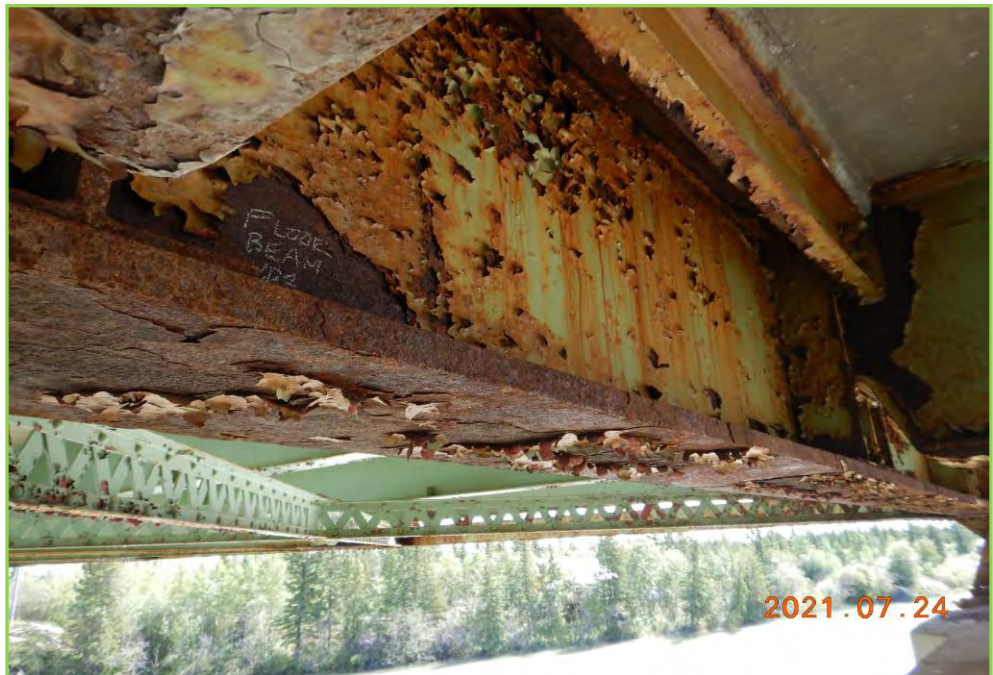
**Photo 064 –**  
**Floor Beam L1 of Span**  
**4 at Pier 3, Pack**  
**Rusting, Light**  
**Corrosion with Minor**  
**Section Loss**

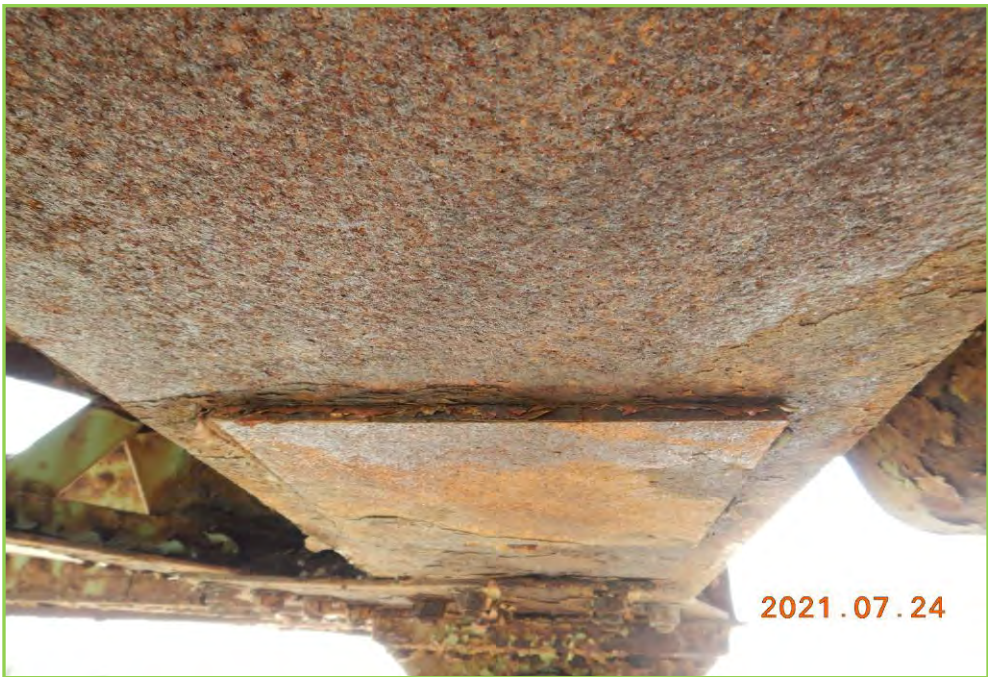
**Photo 065 –  
Girder End of Exterior  
Girder at Span 3,  
Light Corrosion with  
Minor Section Loss**

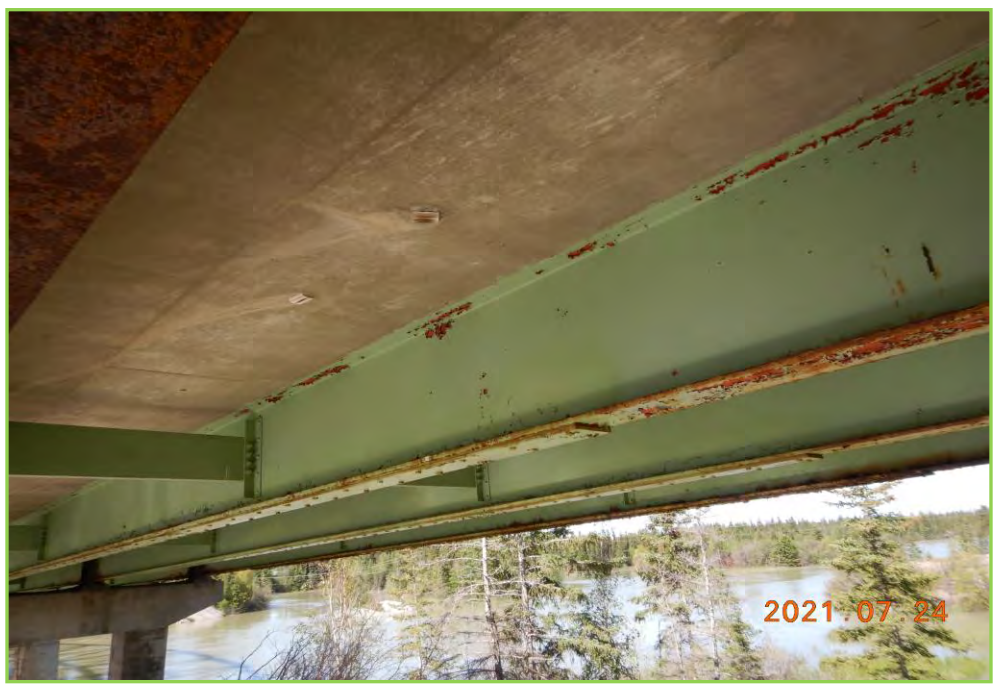
**Photo 066 –  
Interior Girder at Span  
3, General in Good  
Condition**

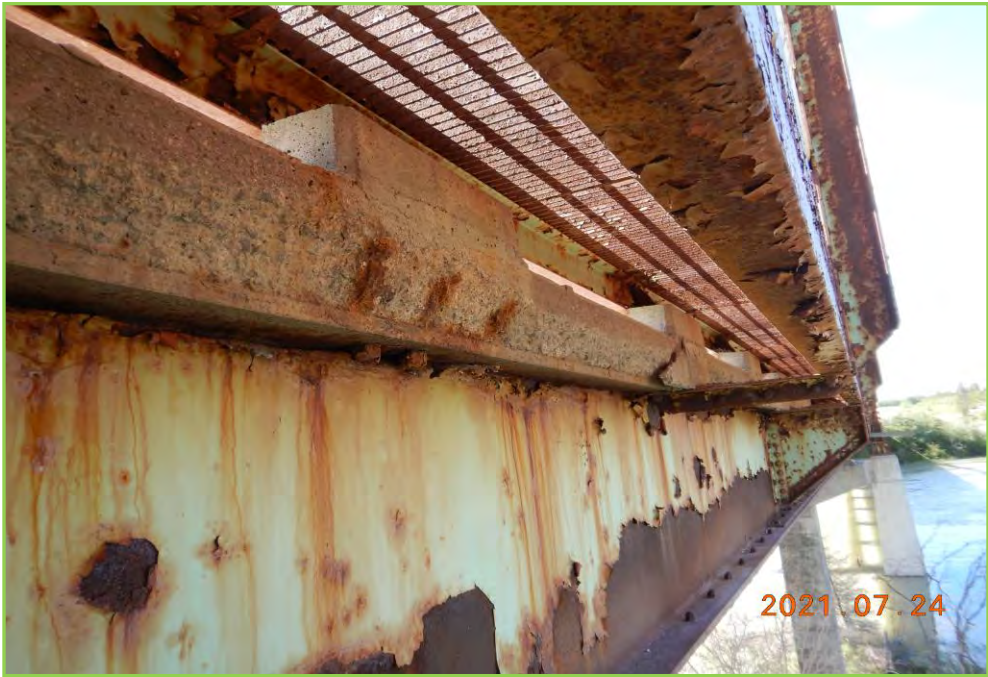
**Photo 067 –  
Exterior Girder (G4)  
at Span 3, US, Light  
Corrosion with Minor  
Section Loss**

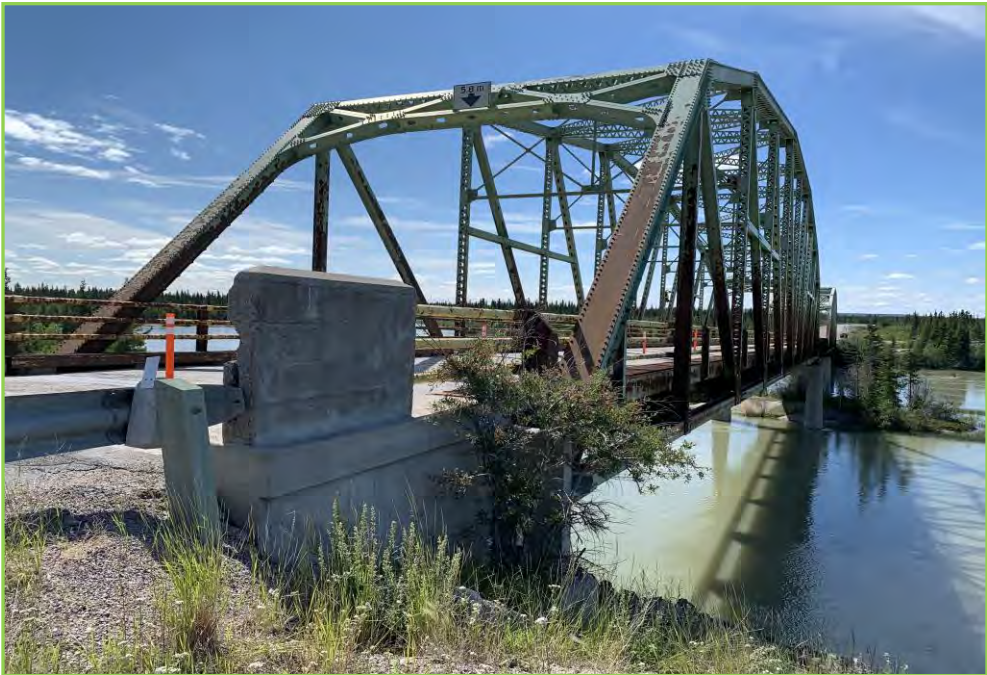
**Photo 068 –  
Concrete Parapet and  
Wingwall at Northeast,  
Abutment 2**

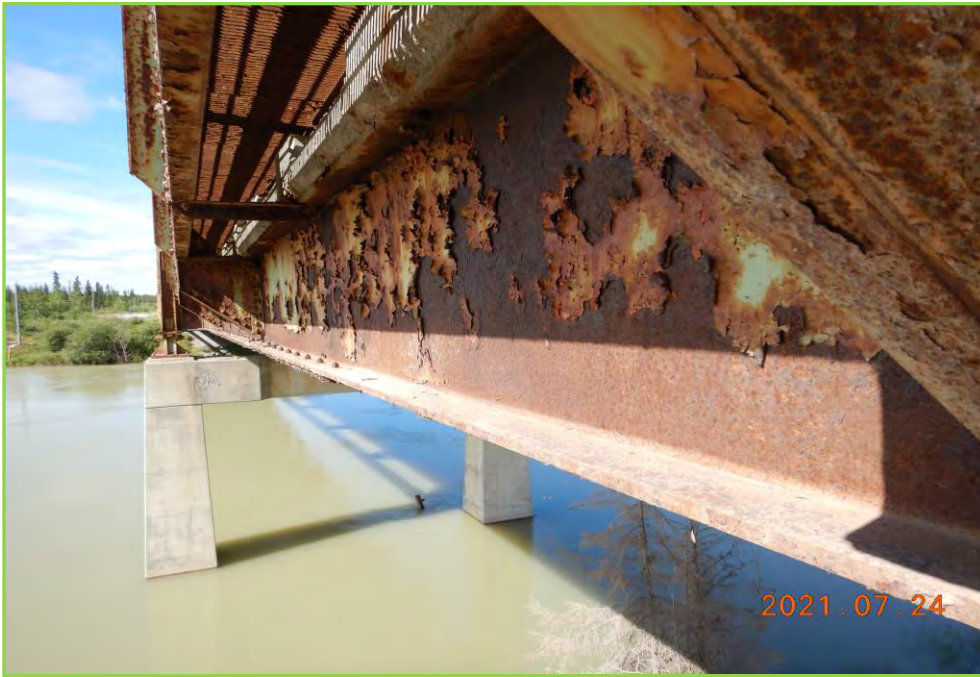
**Photo 063 –  
Typical Exterior  
Girder at Span 2,  
Light Corrosion with  
Minor Section Loss**

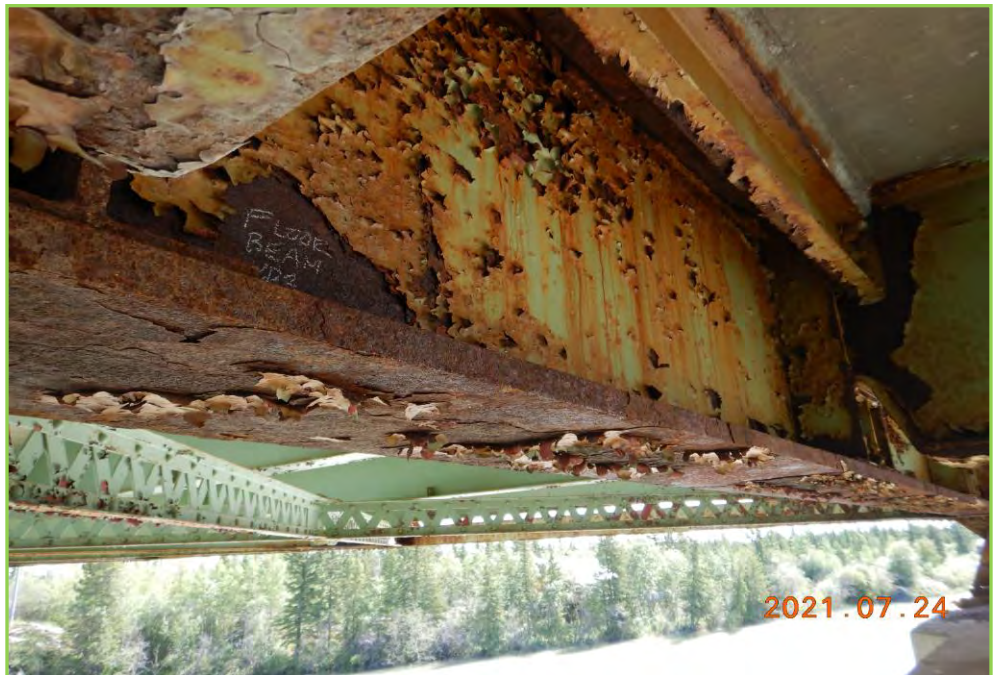
**Photo 064 –  
Floor Beam L1 of Span  
4 at Pier 3, Pack  
Rusting , Light  
Corrosion with Minor  
Section Loss**

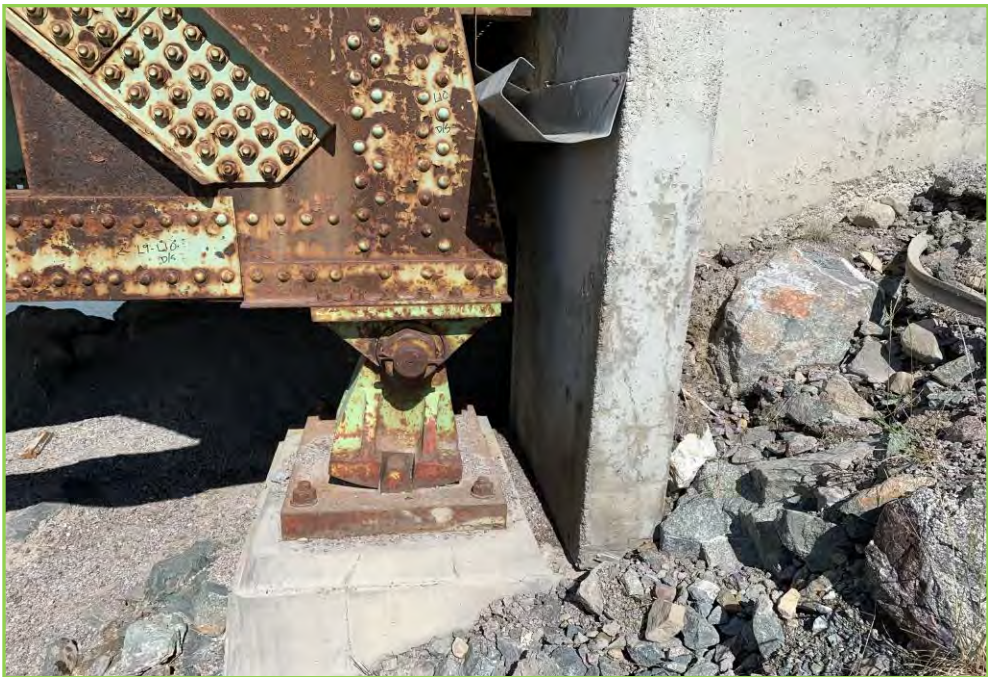
Photo 075 –  
Rock Bearing at Southeast, Light Corrosion

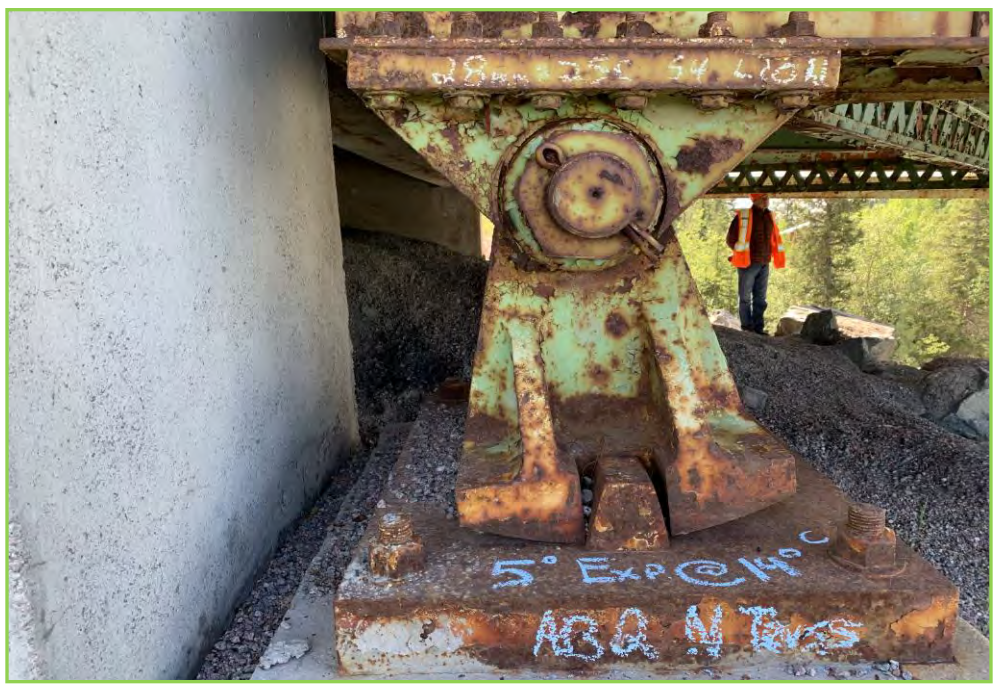
Photo 076 –  
Rock Bearing at Southeast, Light Corrosion

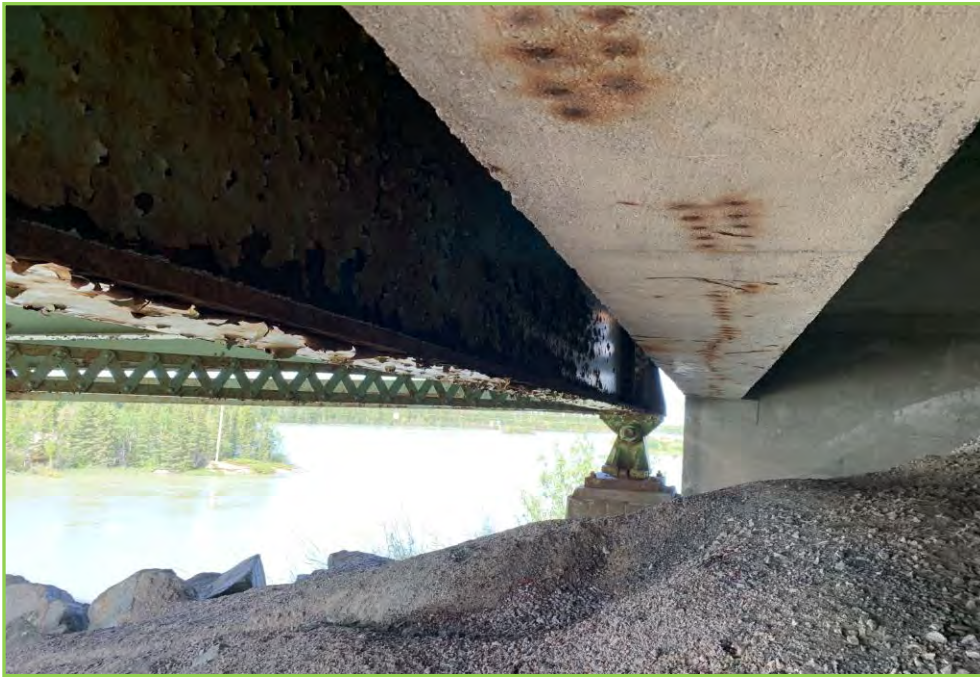
**Photo 079 –  
Bottom of Ballast Wall  
at Abutment 2,  
Staining due to Rebar  
Corrosion with not  
Enough Cover**

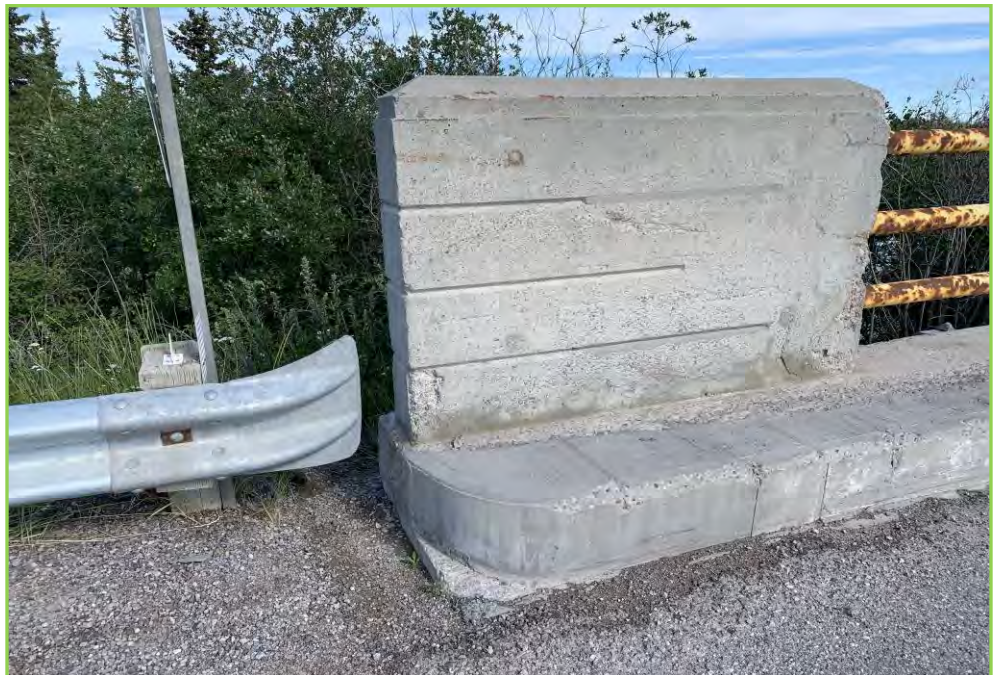
**Photo 080 –  
Guardrail at Abutment  
1, Northwest, No  
Connection to Concrete  
Barrier**

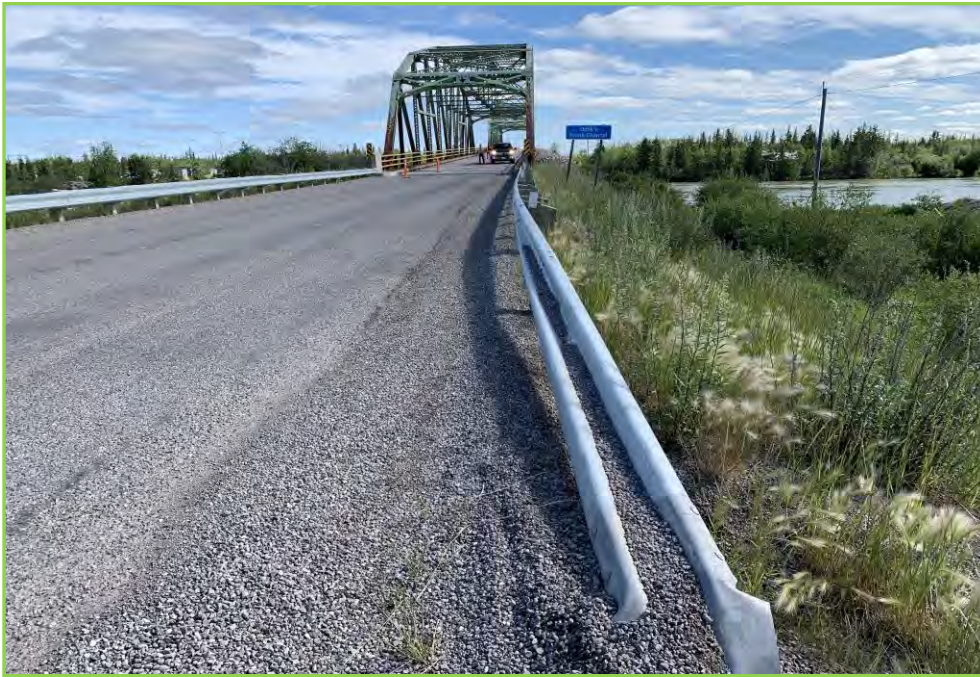
**Photo 081 –  
Turndown End  
Treatment at  
Southwest, Typical in  
Good Condition**

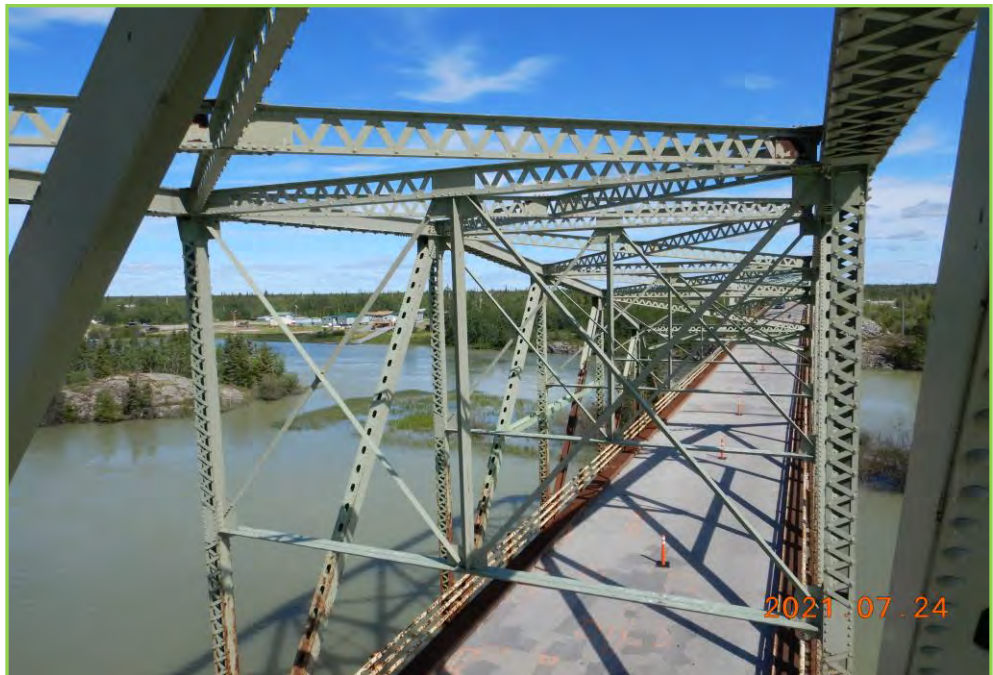
**Photo 082 –  
Top Chord and  
Bracings are in Good  
Condition, Span 1**

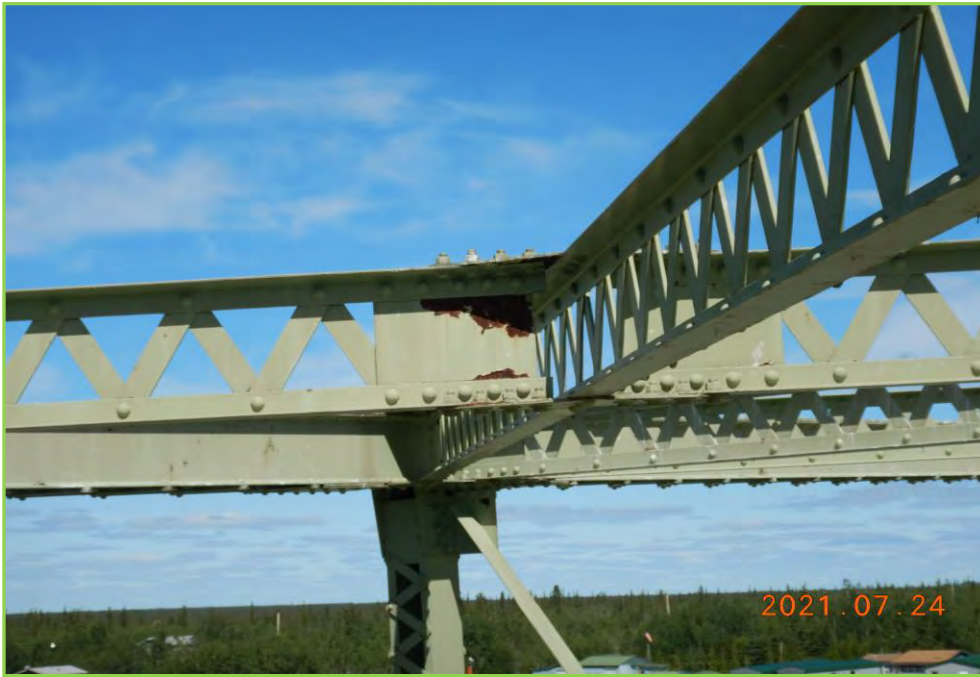
**Photo 083 –  
Span 1, Truss  
Element, Light  
Corrosion at the  
Connection of Sway  
Bracings**

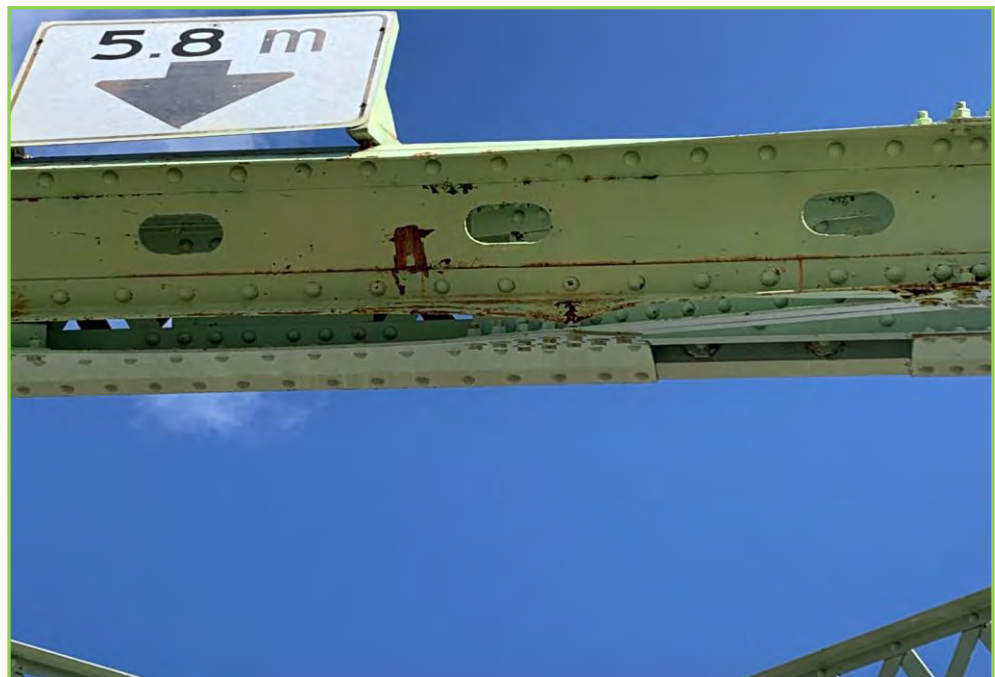
**Photo 084 –  
Span 1 Portal, Minor  
Deformed on the  
Bracing Due to High  
Load Damage**

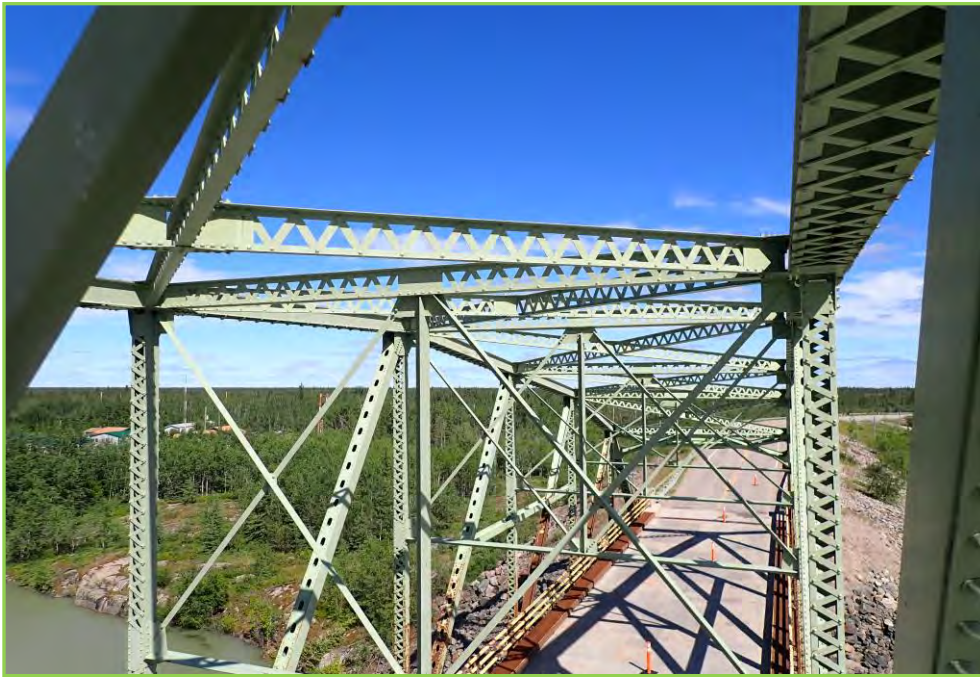
**Photo 085 –  
Top Chord and  
Bracings are in Good  
Condition, Span 4**

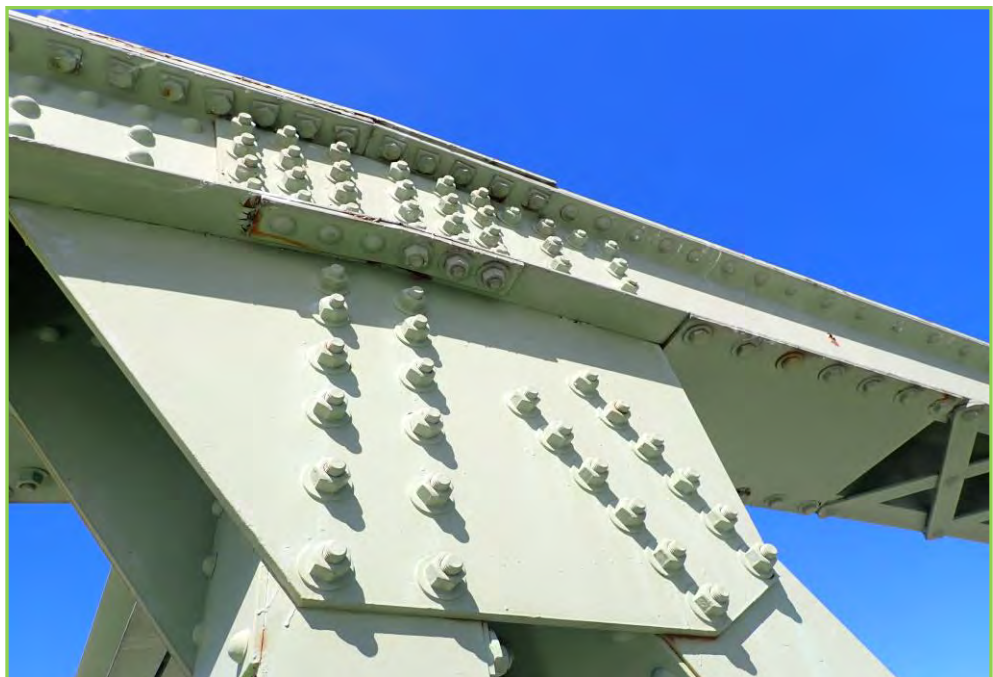
**Photo 086 –  
Connection of the top  
Chord and  
Vertical/Diagonal,  
Typical Good  
Condition, Span 4**

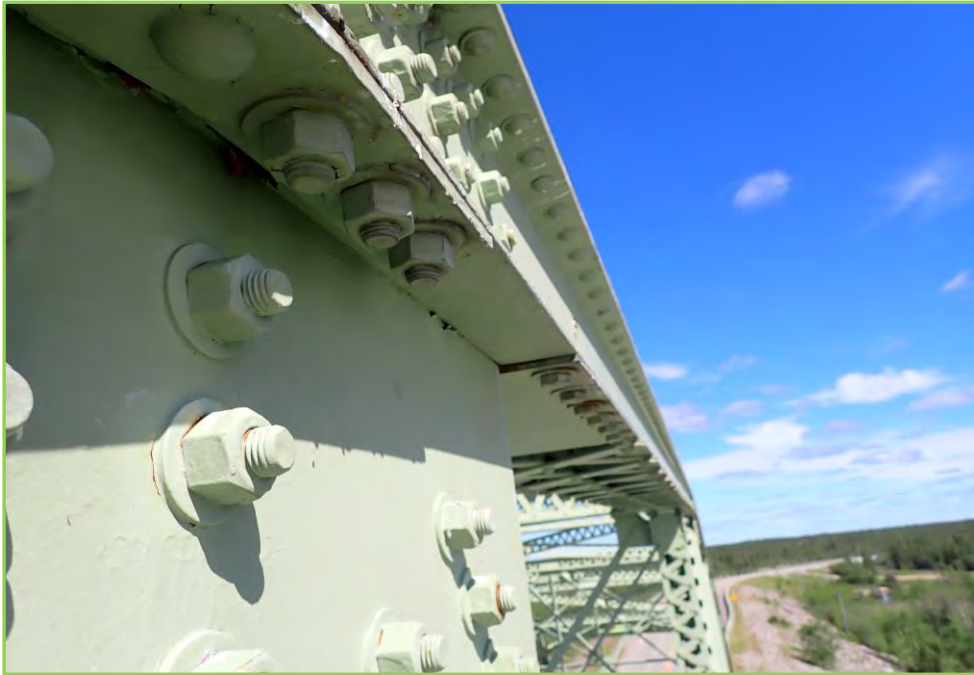
Project No <b>1135510101</b>
	Project: <b>Highway 3 Frank Channel Bridge Inspection</b>
Location: <b>Behchoko, NT</b>	By: <b>Ren Cheng, P. Eng.</b>
Date: <b>July 24, 2021</b>	Page: <b>44 / 49</b>

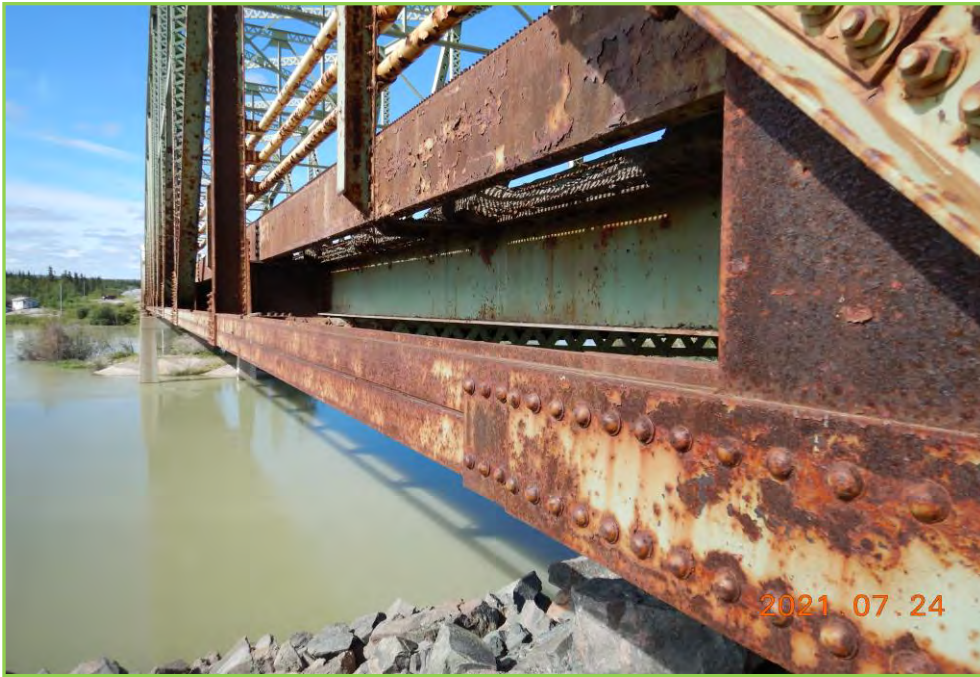
**Photo 091 –  
Bottom Chord at Span 4, DS. Light Corrosion with Minor Section Loss**

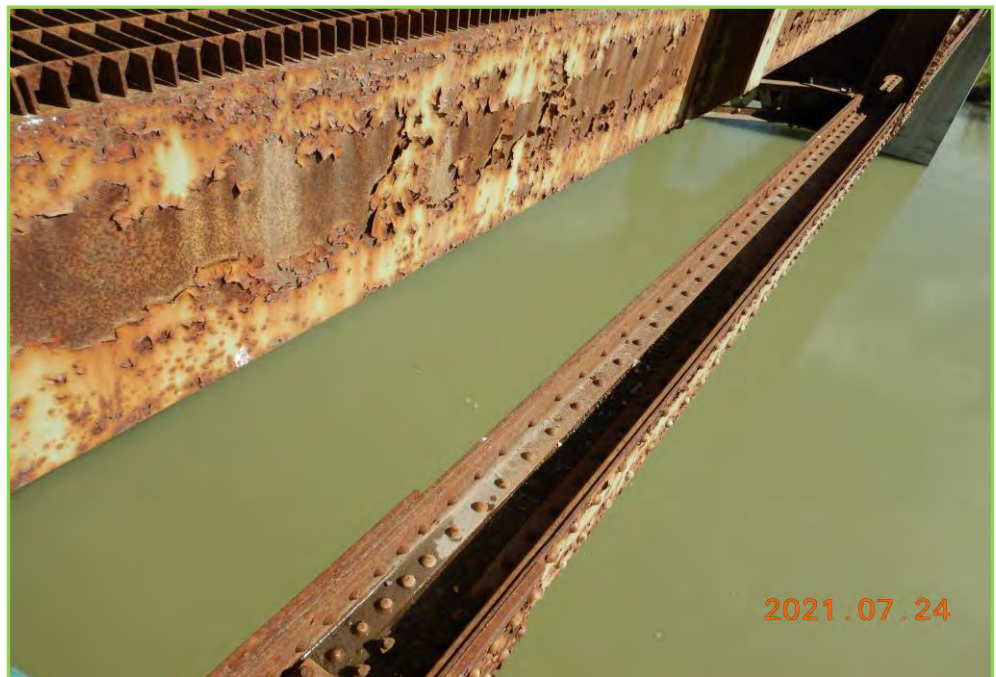
**Photo 092 –  
Bottom Chord at Span 1, DS. Light Corrosion with Minor Section Loss**

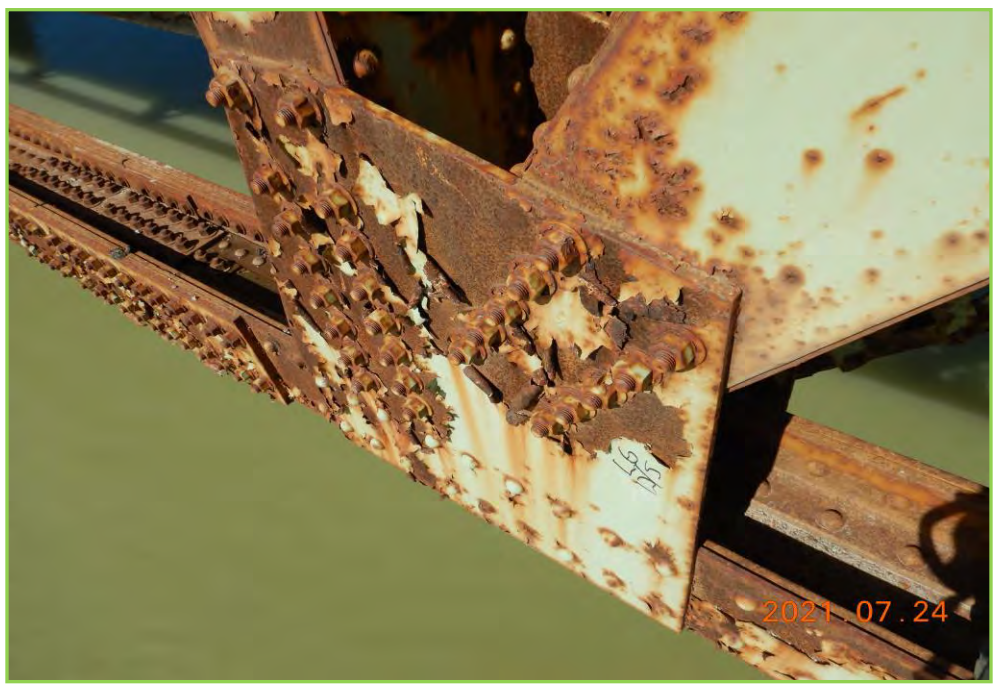
Photo 094 –  
Truss Connections at  
Span 4, Typical Light  
Corrosion with Minor  
Section Loss

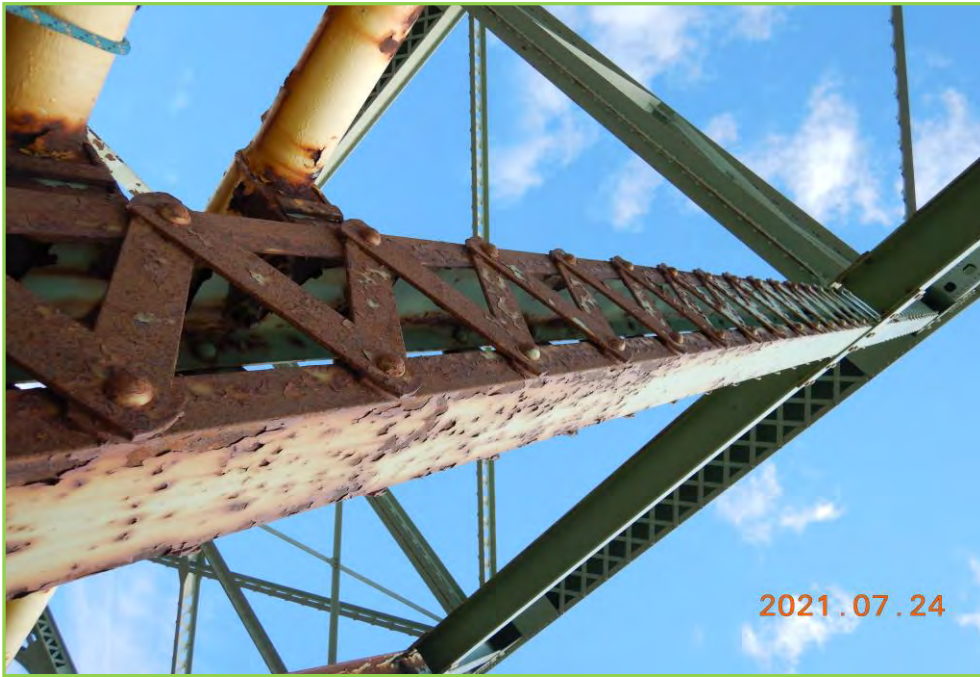
**Photo 095 –  
Vertical at Span 4,  
Typical Light  
Corrosion and Minor  
Section Loss at  
Splash Zone**

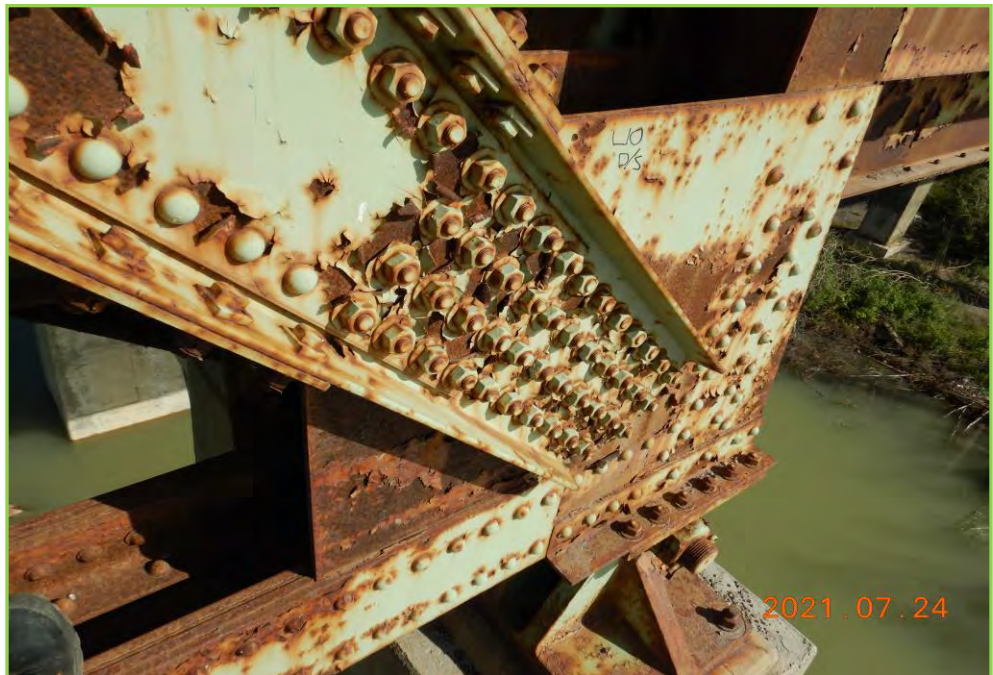
**Photo 096 –  
Truss Connections at  
Pier 1, Span 1, Light  
Corrosion with Minor  
Section Loss**

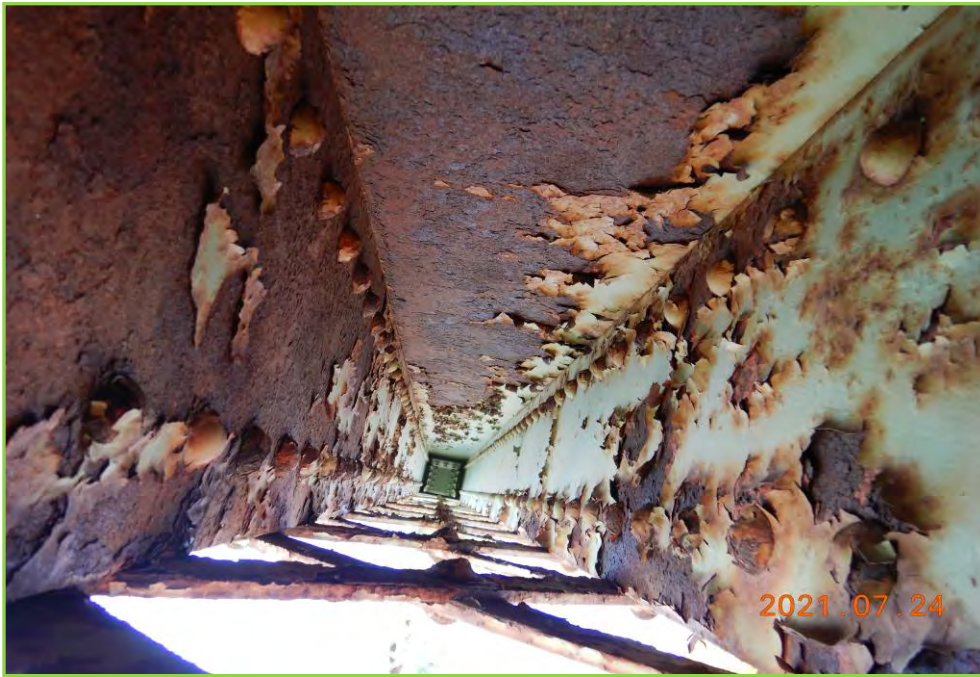
**Photo 097 –**  
**Vertical at Span 1,**  
**Looking inside.**  
**Typical Light**  
**Corrosion and Minor**  
**Section Loss at**  
**Splash Zone**

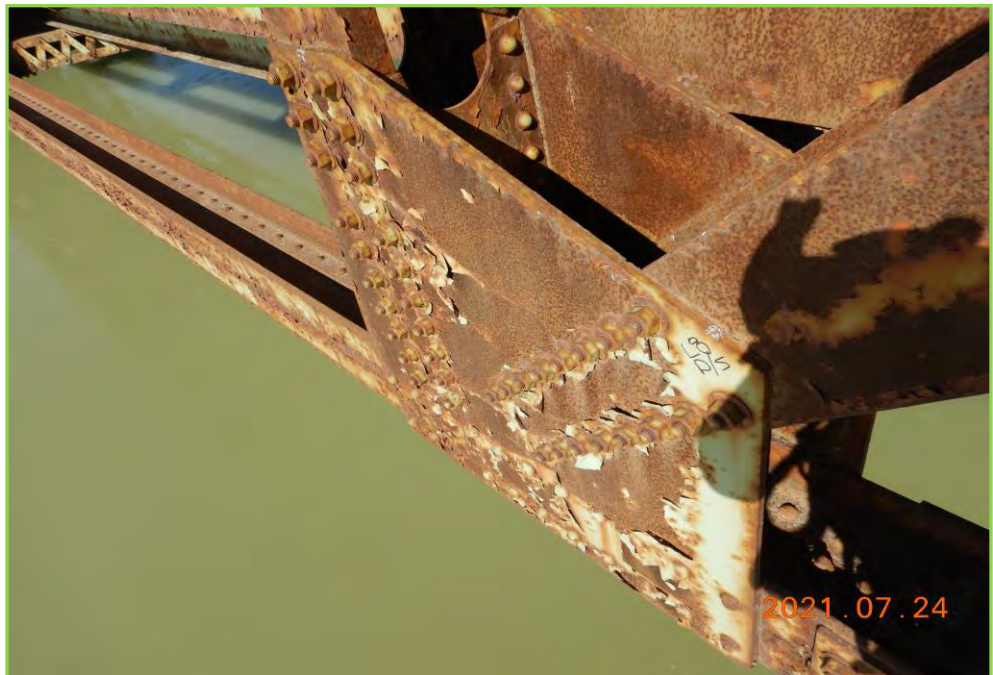
**Photo 098 –**  
**Truss Connections at**  
**Span 1, Light Corrosion**  
**with Minor Section**  
**Loss**
